Spring Creek Watershed Project Implementation Plan Phase Two

Mercer County Soil Conservation District
1400 Hwy 49 North # 102
Beulah ND 58523
701-873-2101
mcsd@westriv.com

Dunn County Soil Conservation District
105 Rodeo Drive
Killdeer, ND 58640
701-764-5646

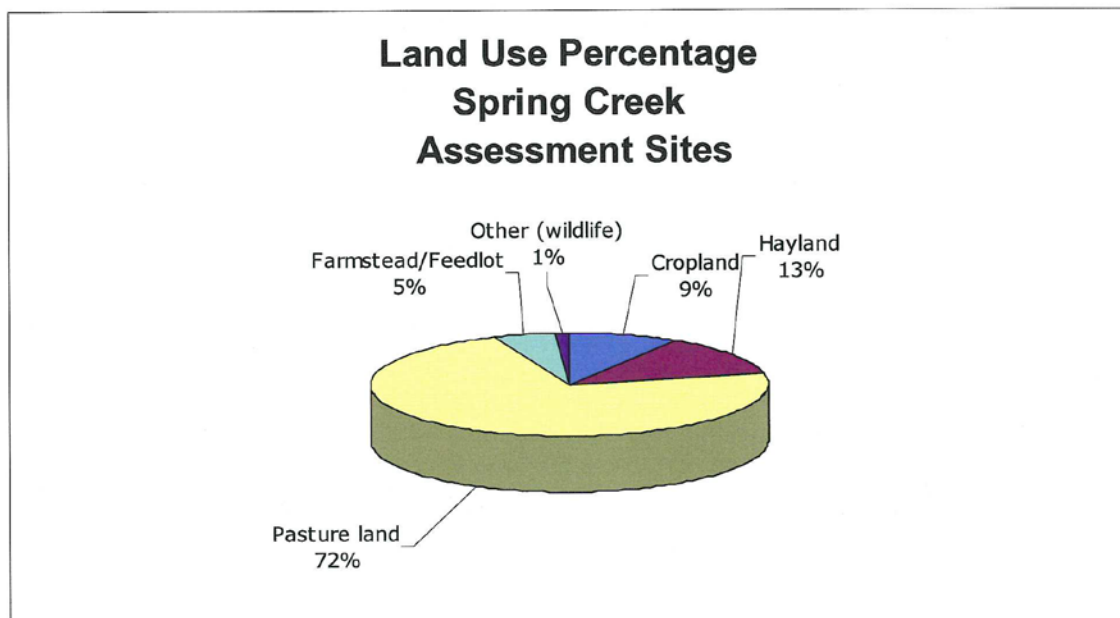
Figure 1 - Spring Creek Land Use (percent)

The pie chart below provides a visual comparison of Spring Creek SVAP site land uses.

Cropland was found on one or both sides of the selected assessment area on 7 of the 50 sites.

Hayland sites, including both tame and native hayland, were found on one or both sides of the assessment area on ten of the 50 sites.

One site was classified as other land. This site was designated as wildlife.
