Evaluating the Cedar Creek and its Watershed

From North of Bowman, ND to the confluence with the Cannonball River

Cedar Creek: Evaluating its Health

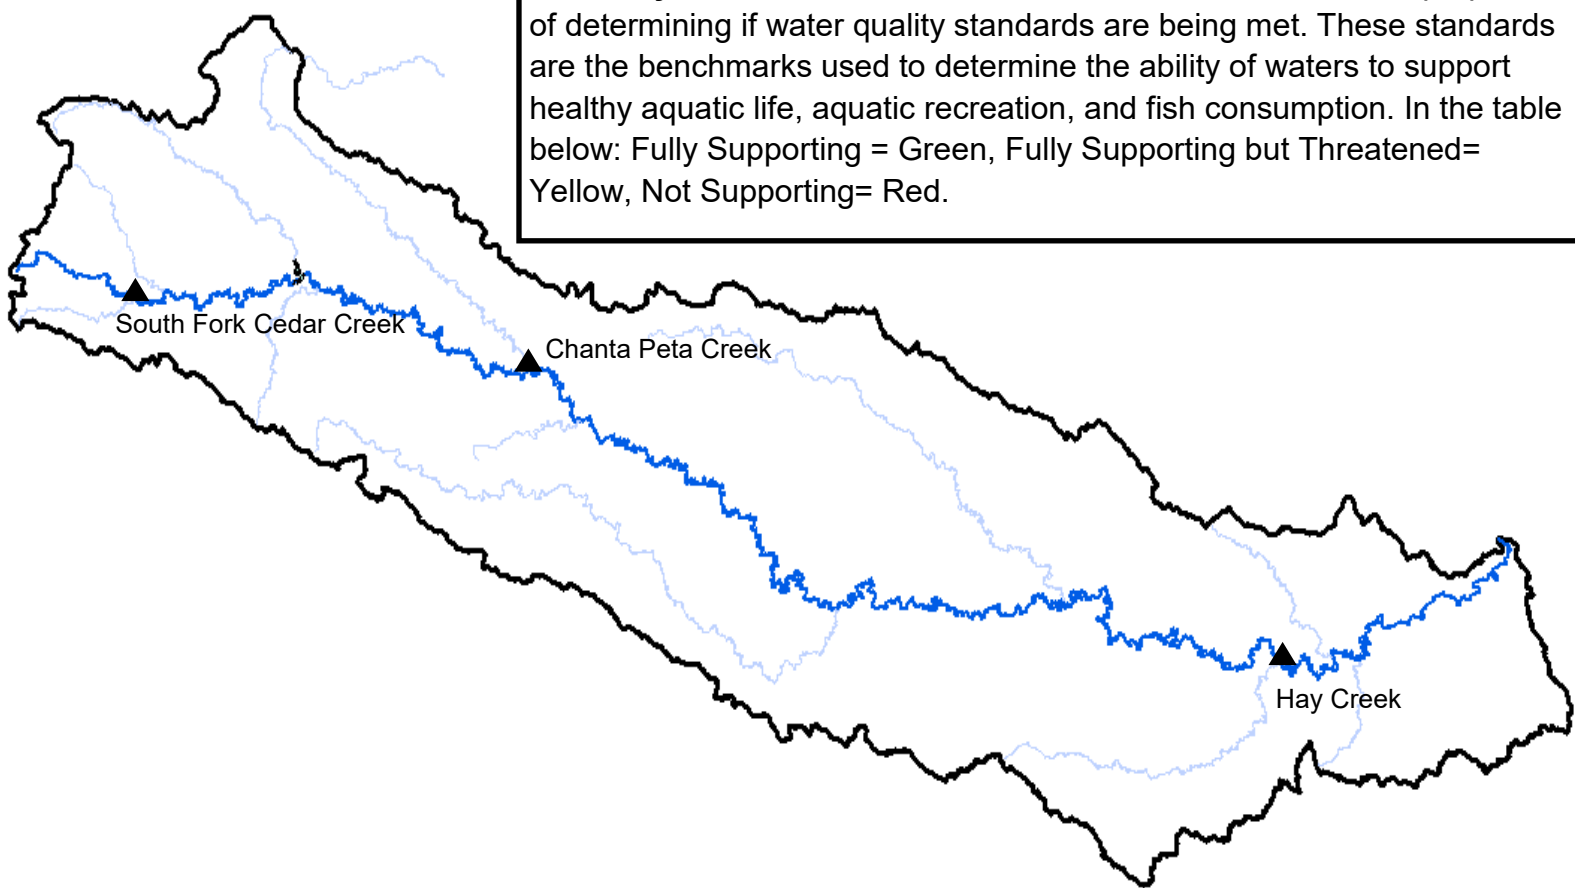
Reach by reach: Cedar Creek is divided into “reaches” for the purpose of determining if water quality standards are being met. These standards are the benchmarks used to determine the ability of waters to support healthy aquatic life, aquatic recreation, and fish consumption. In the table below: Fully Supporting = Green, Fully Supporting but Threatened= Yellow, Not Supporting= Red.

Reach Description	Aquatic Life	Recreation	Impairments
	Cedar Creek from its confluence with Hay Creek , downstream to its confluence with the Cannonball River. Located on the boarder of Grant and Sioux Counties.		
Cedar Creek from Cedar Lake, downstream to its confluence with Chanta Peta Creek . Located in Adams County.			<ul style="list-style-type: none"> Not Supporting Aquatic Life due to Benthic-Macroinvertebrate Bioassessments.
Cedar Creek from its confluence with South Fork Cedar Creek , downstream to Cedar Lake. Located in Slope and Bowman County.			<ul style="list-style-type: none"> Fully Supporting, but Threatened Aquatic Life due to Sedimentation/ Siltation.
Cedar Creek upstream from its confluence with South Fork Cedar Creek , including all tributaries. Located in Bowman and Slope counties.			<ul style="list-style-type: none"> Fully Supporting, but Threatened Aquatic Life due to Sedimentation/ Siltation.
