Evaluating the James River and its Watershed

From Hurdsfield, ND to the South Dakota Border

The James River: Evaluating its Health

Improving water quality in the James River basin

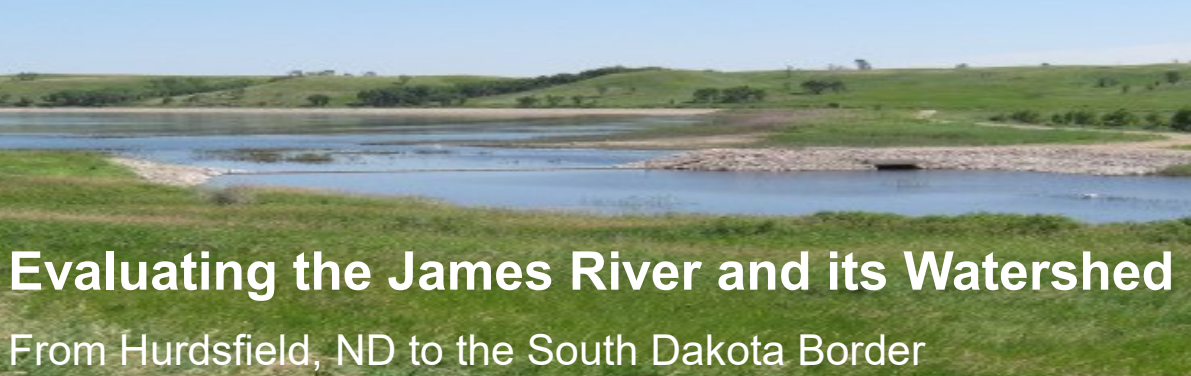
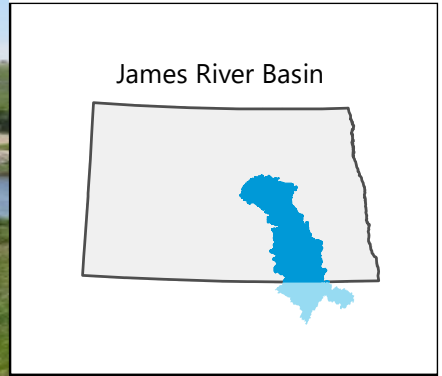
James River Basin

Biological Indicators: Aquatic Macroinvertebrates are the most common organisms used in water quality assessments because they are easy to collect, exhibit high diversity, are rapid colonizers, and are a vital link in the food web.

Swimmers and Boaters Beware: Harmful Algal Blooms (HABs) are becoming more prevalent in recreational waterbodies. HABs cause toxins that can be harmful to humans, pets, and livestock.

Fish Species: The three most abundant fish species are non-game species, 1) fathead minnow, 2) sand shiner, and 3) white sucker.

More Water: Increased rain events combined with an ag dominated landscape brings more pollutants to the river from the landscape, such as sediment, bacteria, and nutrients.

Downstream Damage: The river doesn't stop at the boarder. Pollutants continue south and flow into South Dakota. What are our responsibilities to our neighbors?

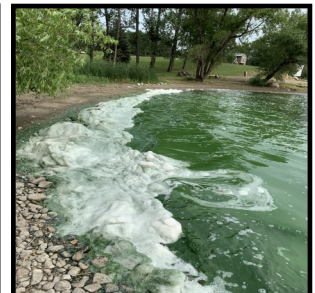
Harmful Algal Blooms (HABS)

Excess nutrients cause HABS to appear more frequently and with more severity. Lake LaMoure and Jamestown Reservoir have recurrent blooms that result in advisories and/or warnings.
