Sheyenne River Comprehensive Bank Stability and Restoration Study

VALLEY CITY, ND
2013

North Dakota Water Quality
Monitoring Conference

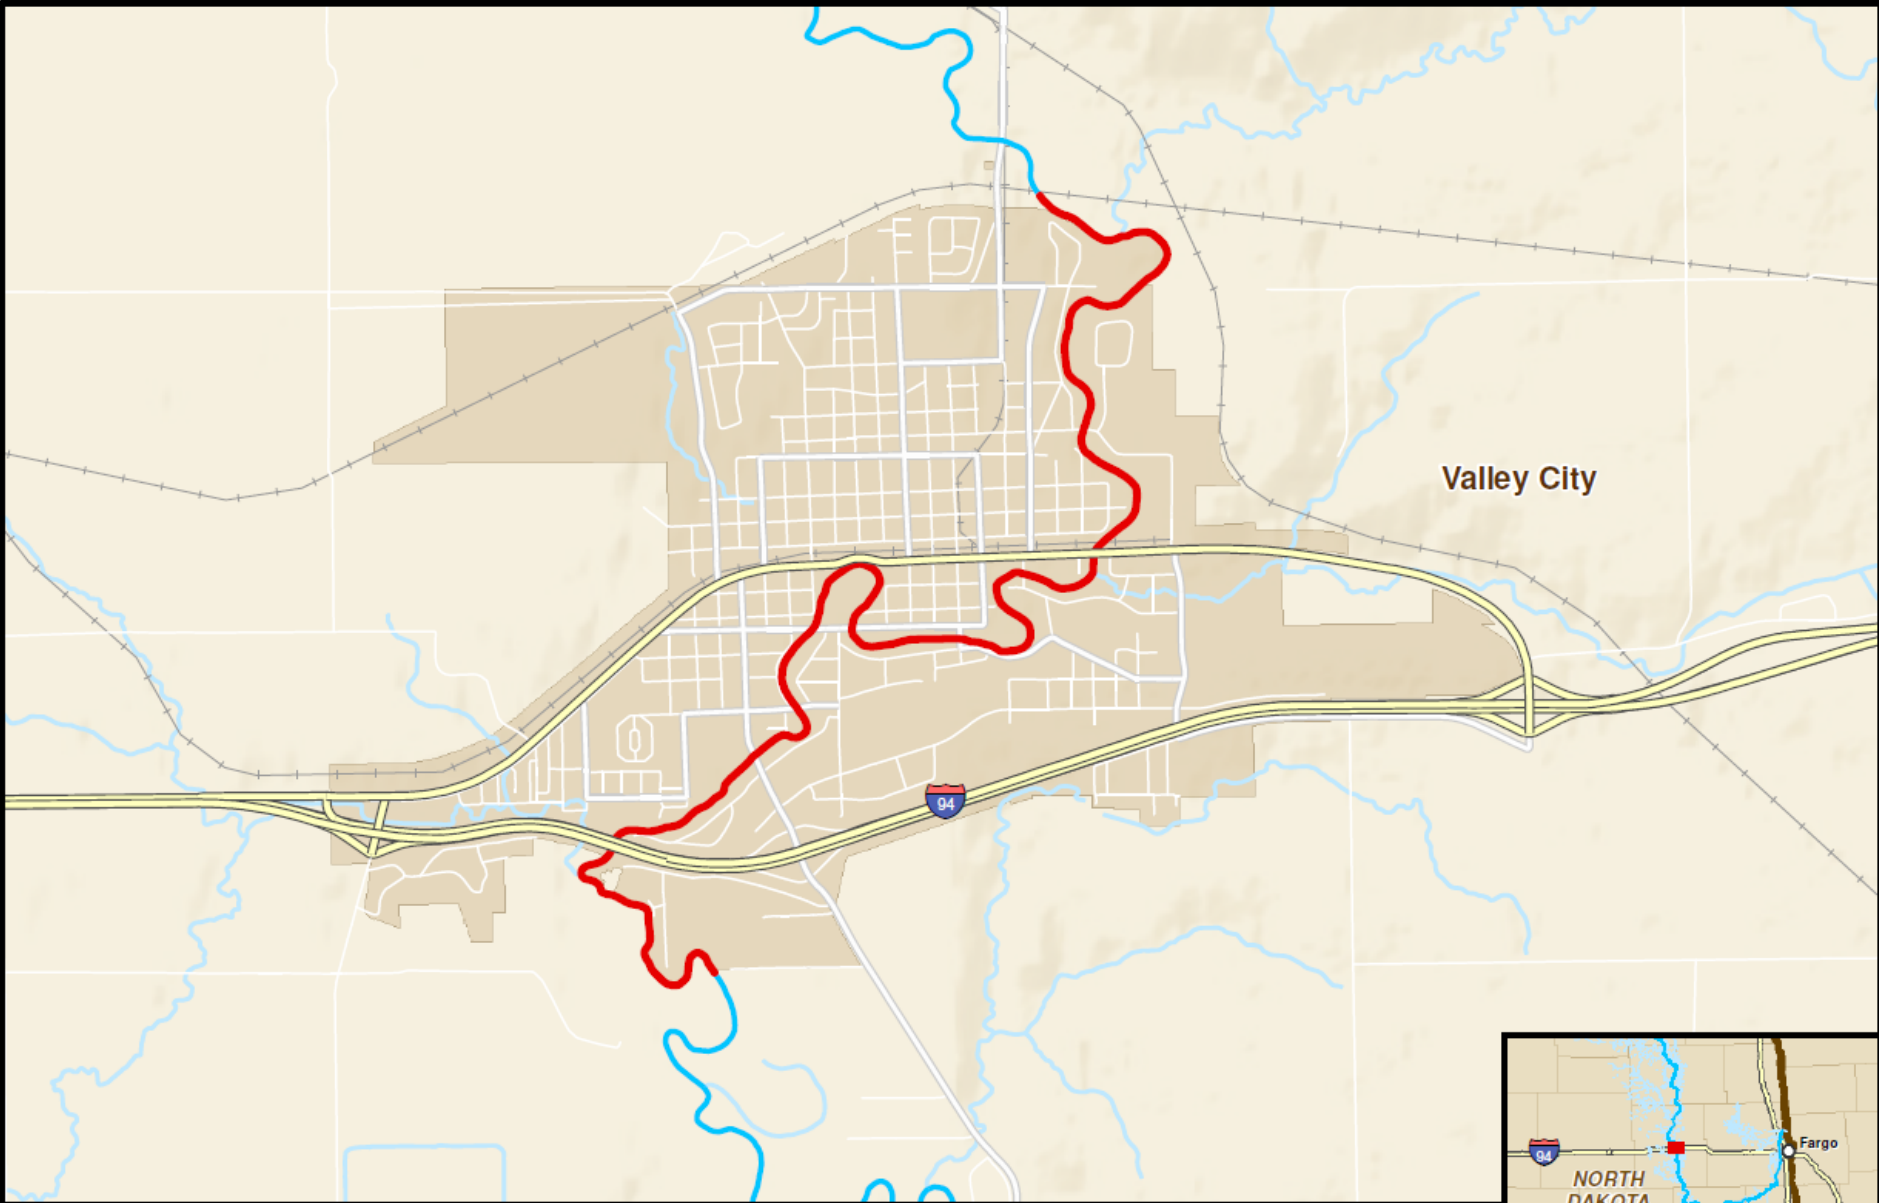
Study Area

Sheyenne River Bank Restoration Study
Valley City, ND
JOB NO. 31811365

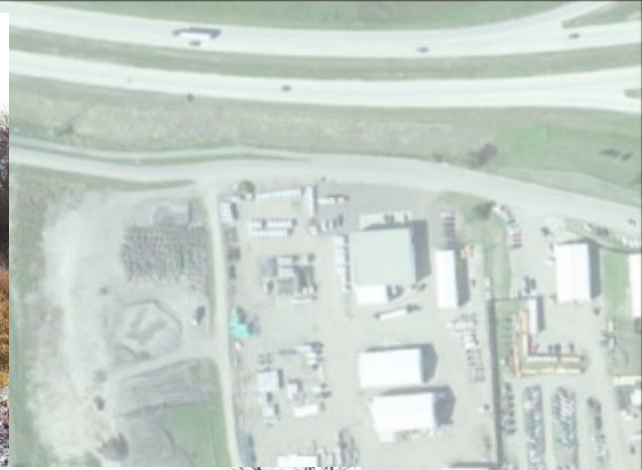
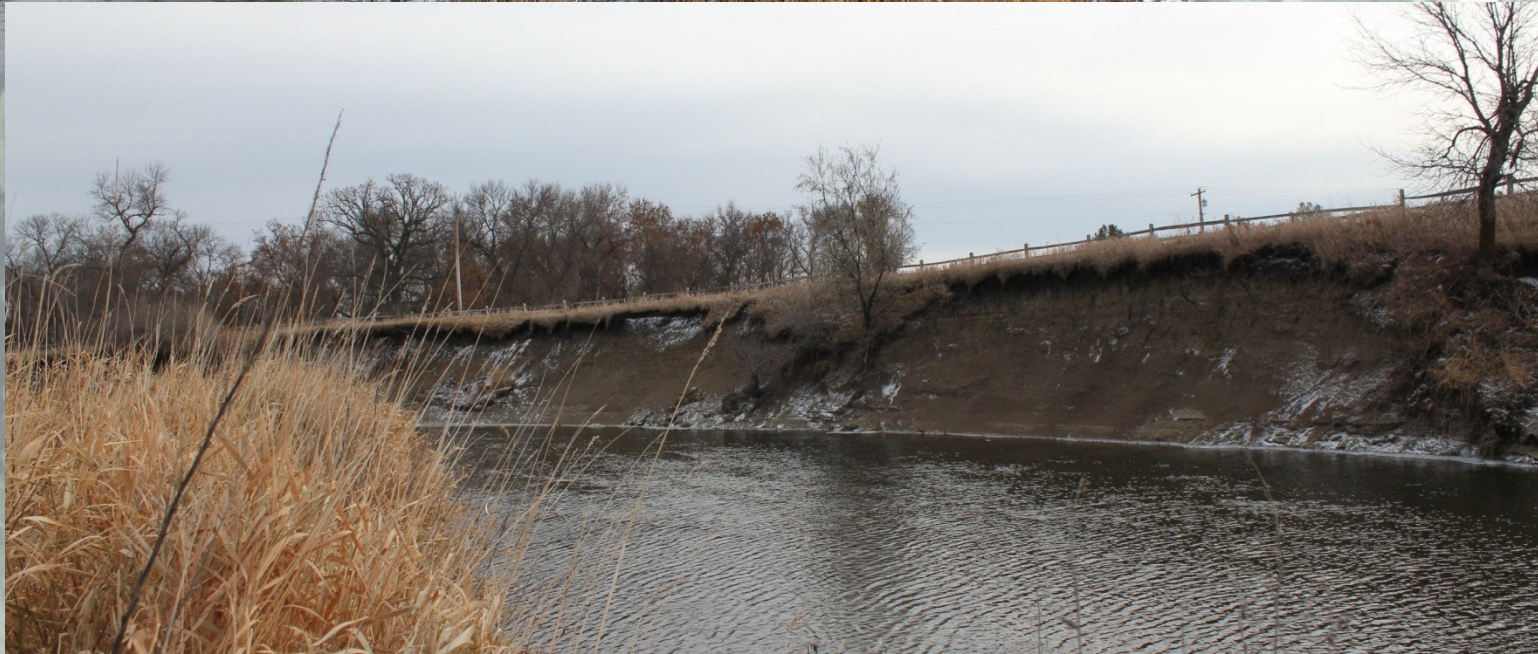
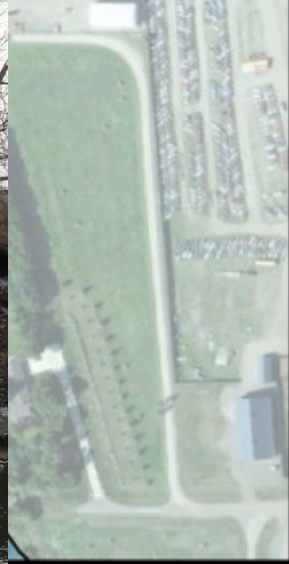
Bank Failure and Artificial Revetment

Sheyenne River Bank Restoration Study
Valley City, ND

- 216 bank elevation points.
- 212 photographs taken from 89 different locations.
- 19 sediment samples from 10 different SSURGO soil mapping units.
- Rapid Geomorphic Assessment (RGA) was completed on 43 individual stream reaches.
- Notes on geomorphology and the presence or absence of artificial revetment were recorded throughout.
