Sargent Central River Watch

Wild Rice River

We tested turbidity, specific conductivity, dissolved oxygen, and pH before and after Tewaukon in order to become aware of any changes that may be a result of the Tewaukon buffer zone.

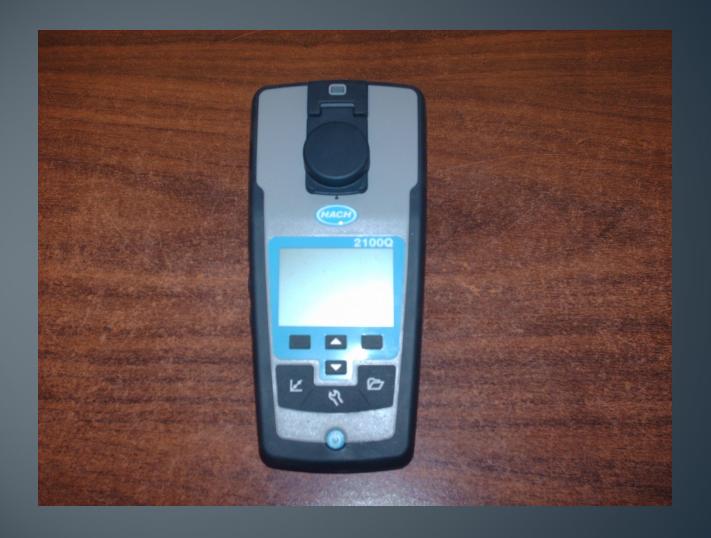
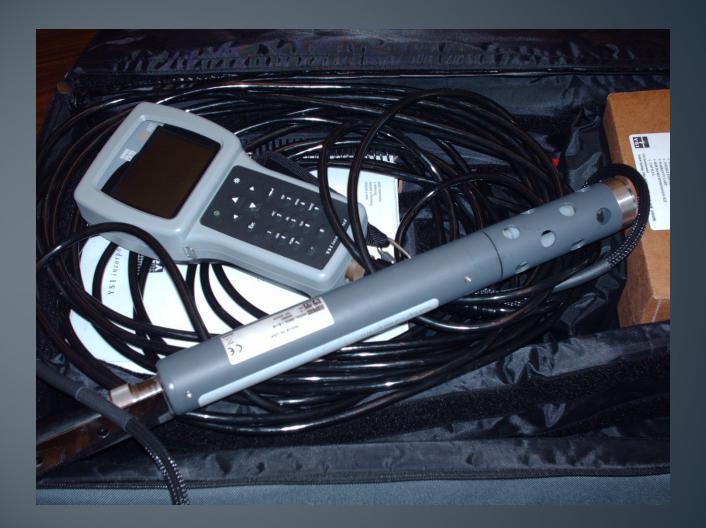
YSI Handheld and Sonde 600 XL

- Hach Turbidimeter
- Water Sampler

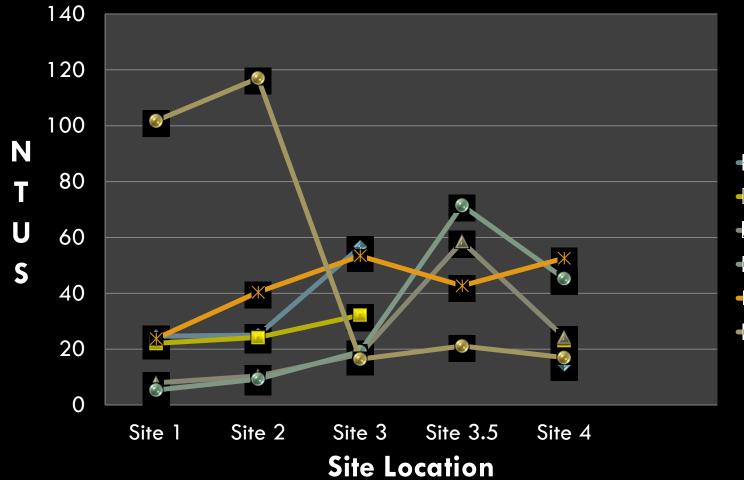
Turbidity 2010-13

- pH increases as water flows through buffer zone as expected due to increased plant activity
- Dissolved oxygen is at high levels. This means that nutrient levels coming in from runoff may be at acceptable levels within the Wild Rice River.
- ⁷ Turbidity is high. Characteristic of muddy North Dakota rivers. Could be caused by the high levels of agriculture around the watershed. Some of our high readings due to seasonal runoff. Ours higher than the USGS test station
 - Specific conductivity was high. Clay soil may contribute to this number. lons for agricultural runoff.
