Red River Valley Subsurface Drainage Water Quality Assessment Phase I & II, 2008 to 2013

Dr. Thomas Scherer
NDSU Extension Agricultural Engineer
Thomas.Scherer@ndsu.edu

2008 Phase I

2009 – 2013 Phase II

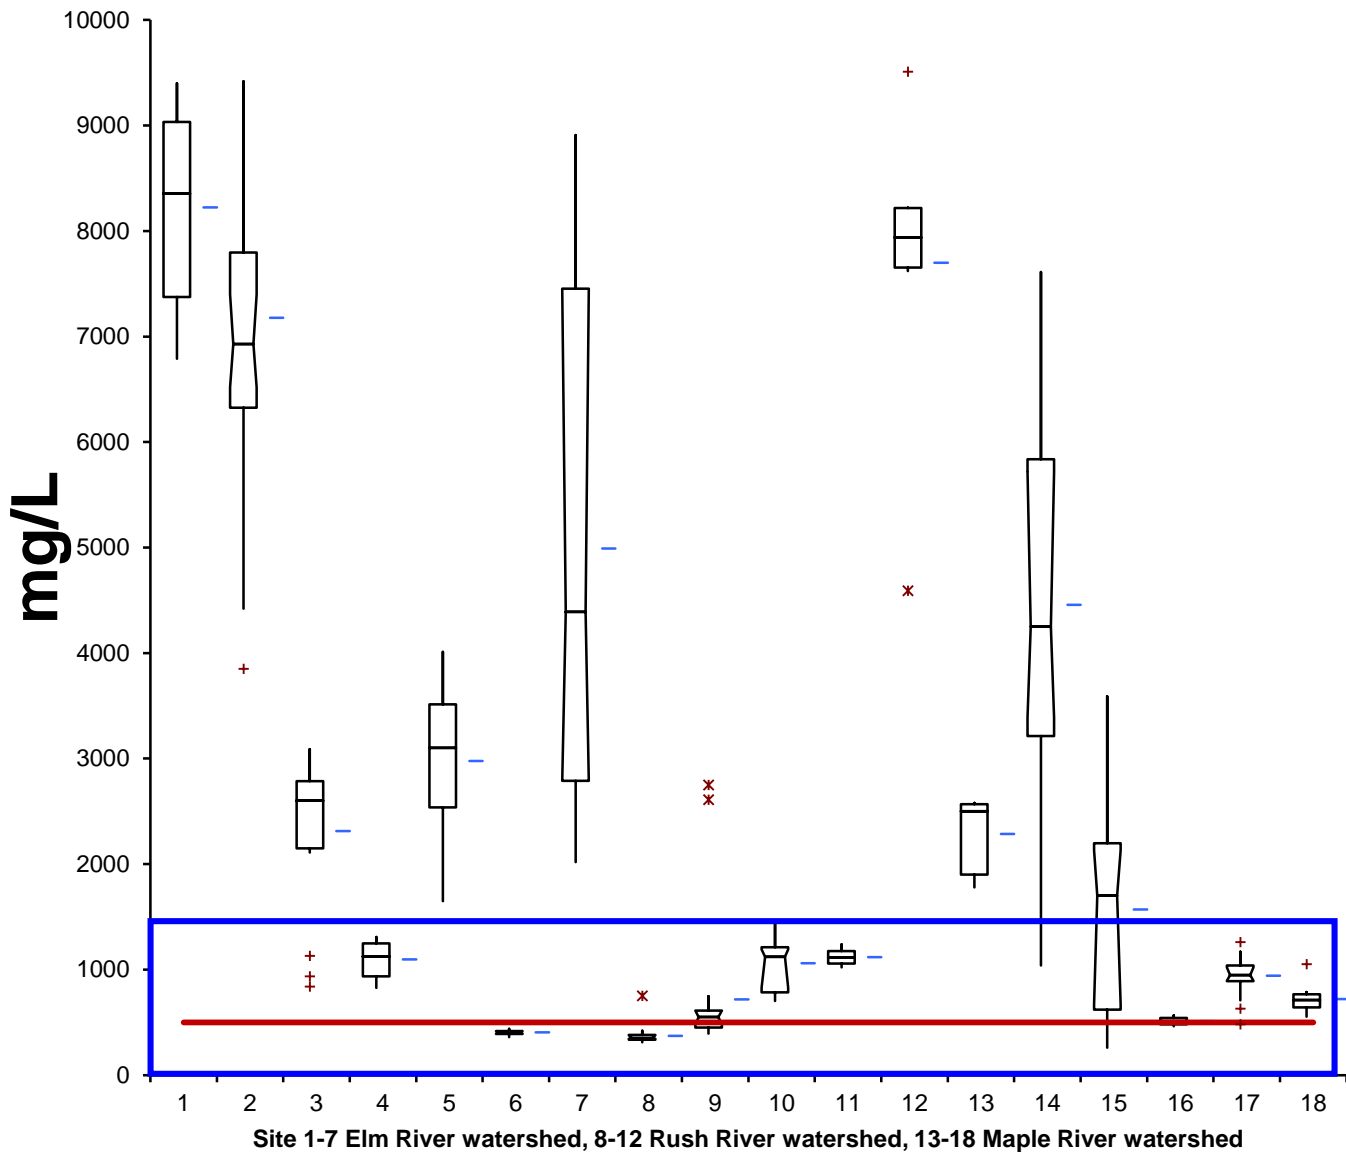
Total Dissolved Salts

- 95% CI Notched Outlier Boxplot
- Mean
- + Outliers > 1.5 and < 3 IQR
- * Outliers > 3 IQR
- National Secondary Drinking Water Standards 500mg/L

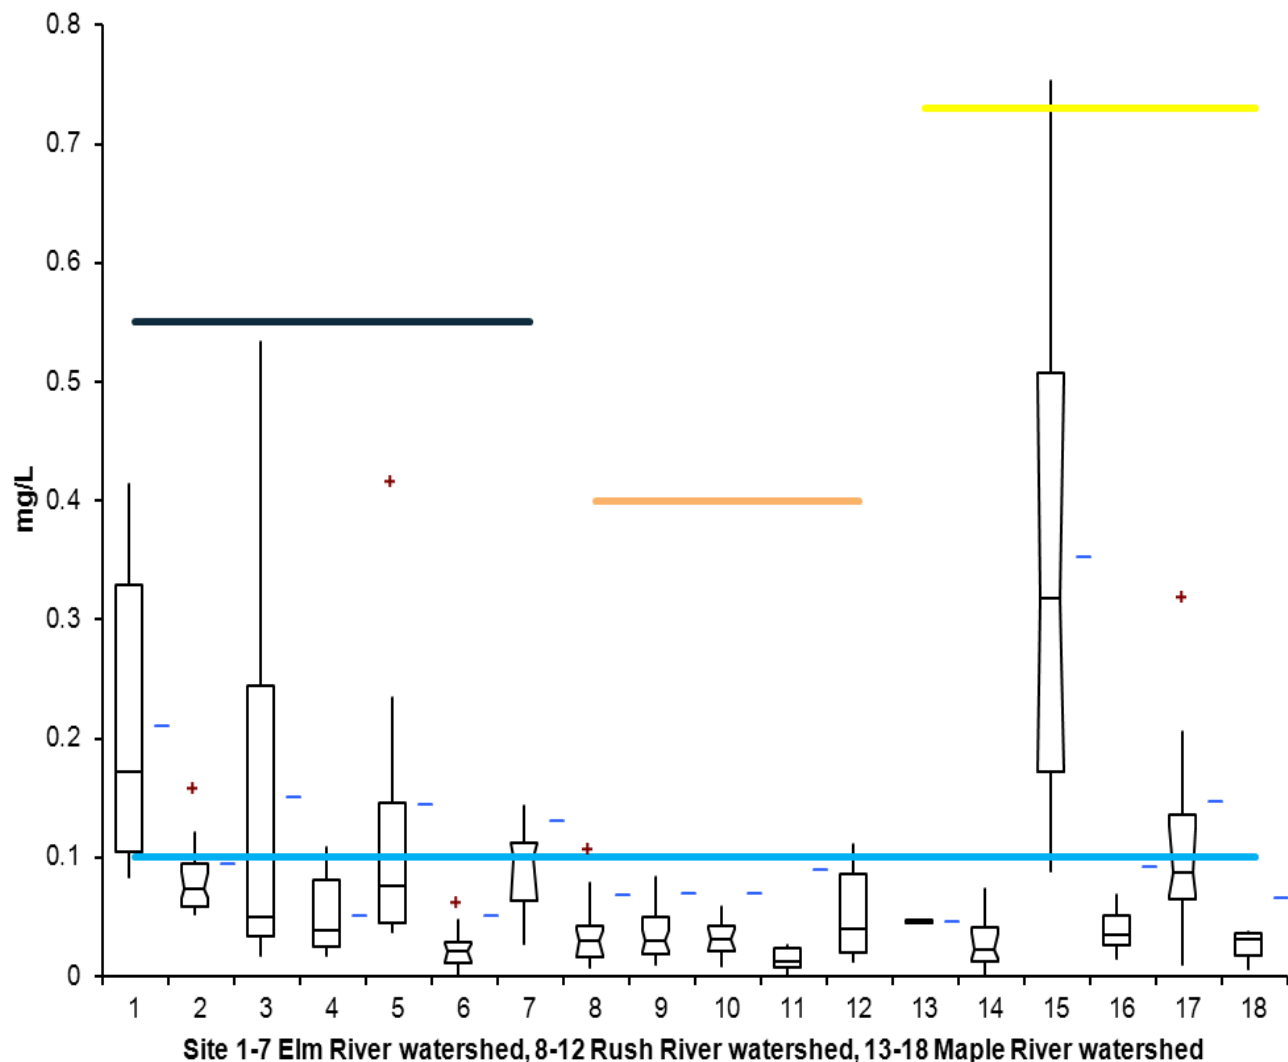
Phosphorus

- 95% CI Notched Outlier Boxplot
- Mean
- + Outliers > 1.5 and < 3 IQR
- Average in 2004-05 study on Rush River 0.4mg/L
- Average in 2007 study on Maple River 0.73mg/L
- Standards of Quality for Waters of the State 0.1mg/L
- Average in 1993 study on Elm River 0.55mg/L

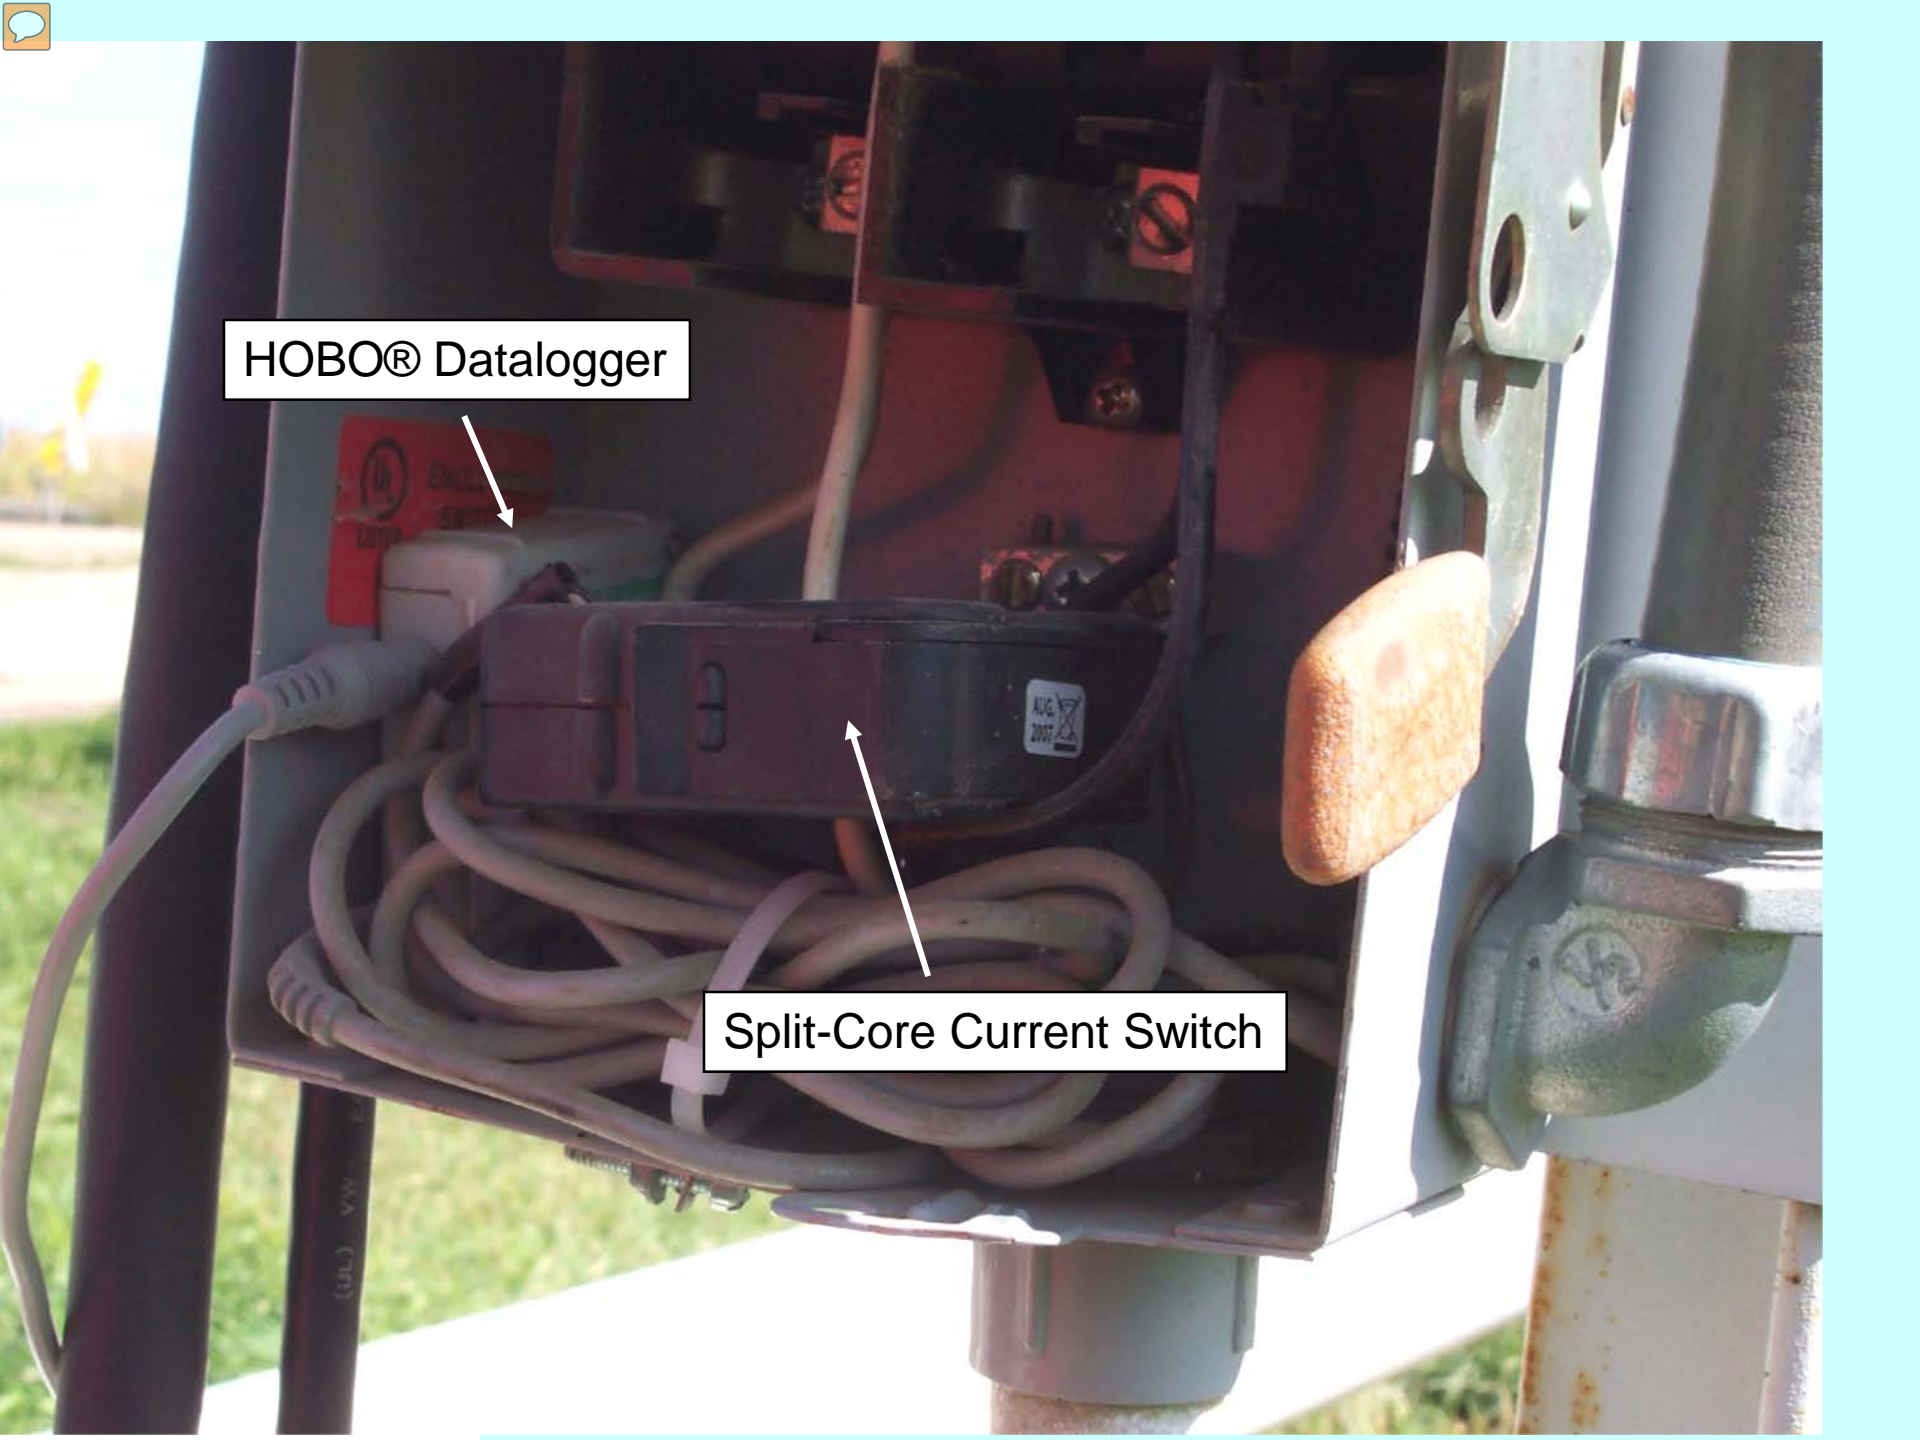
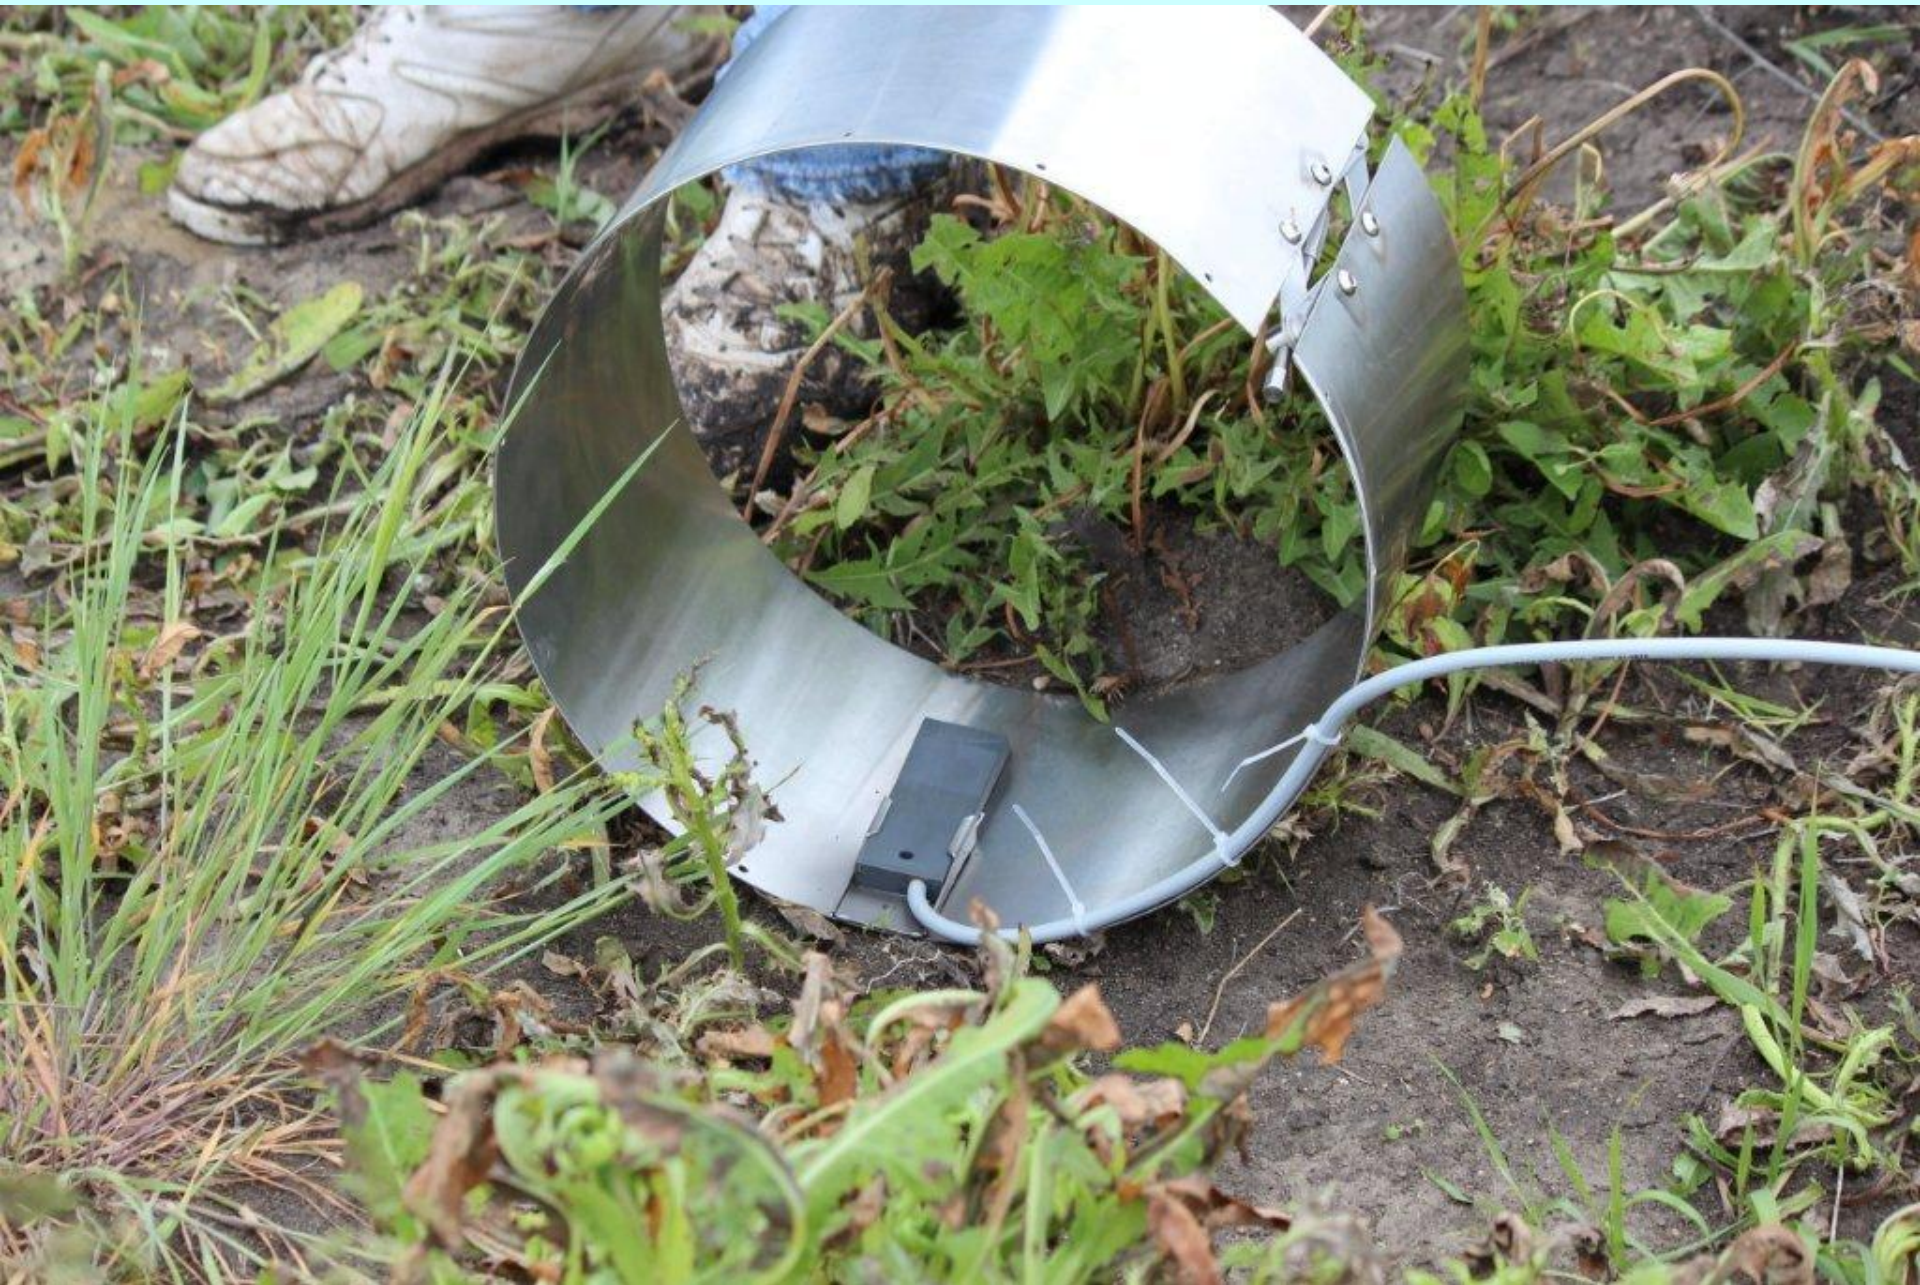
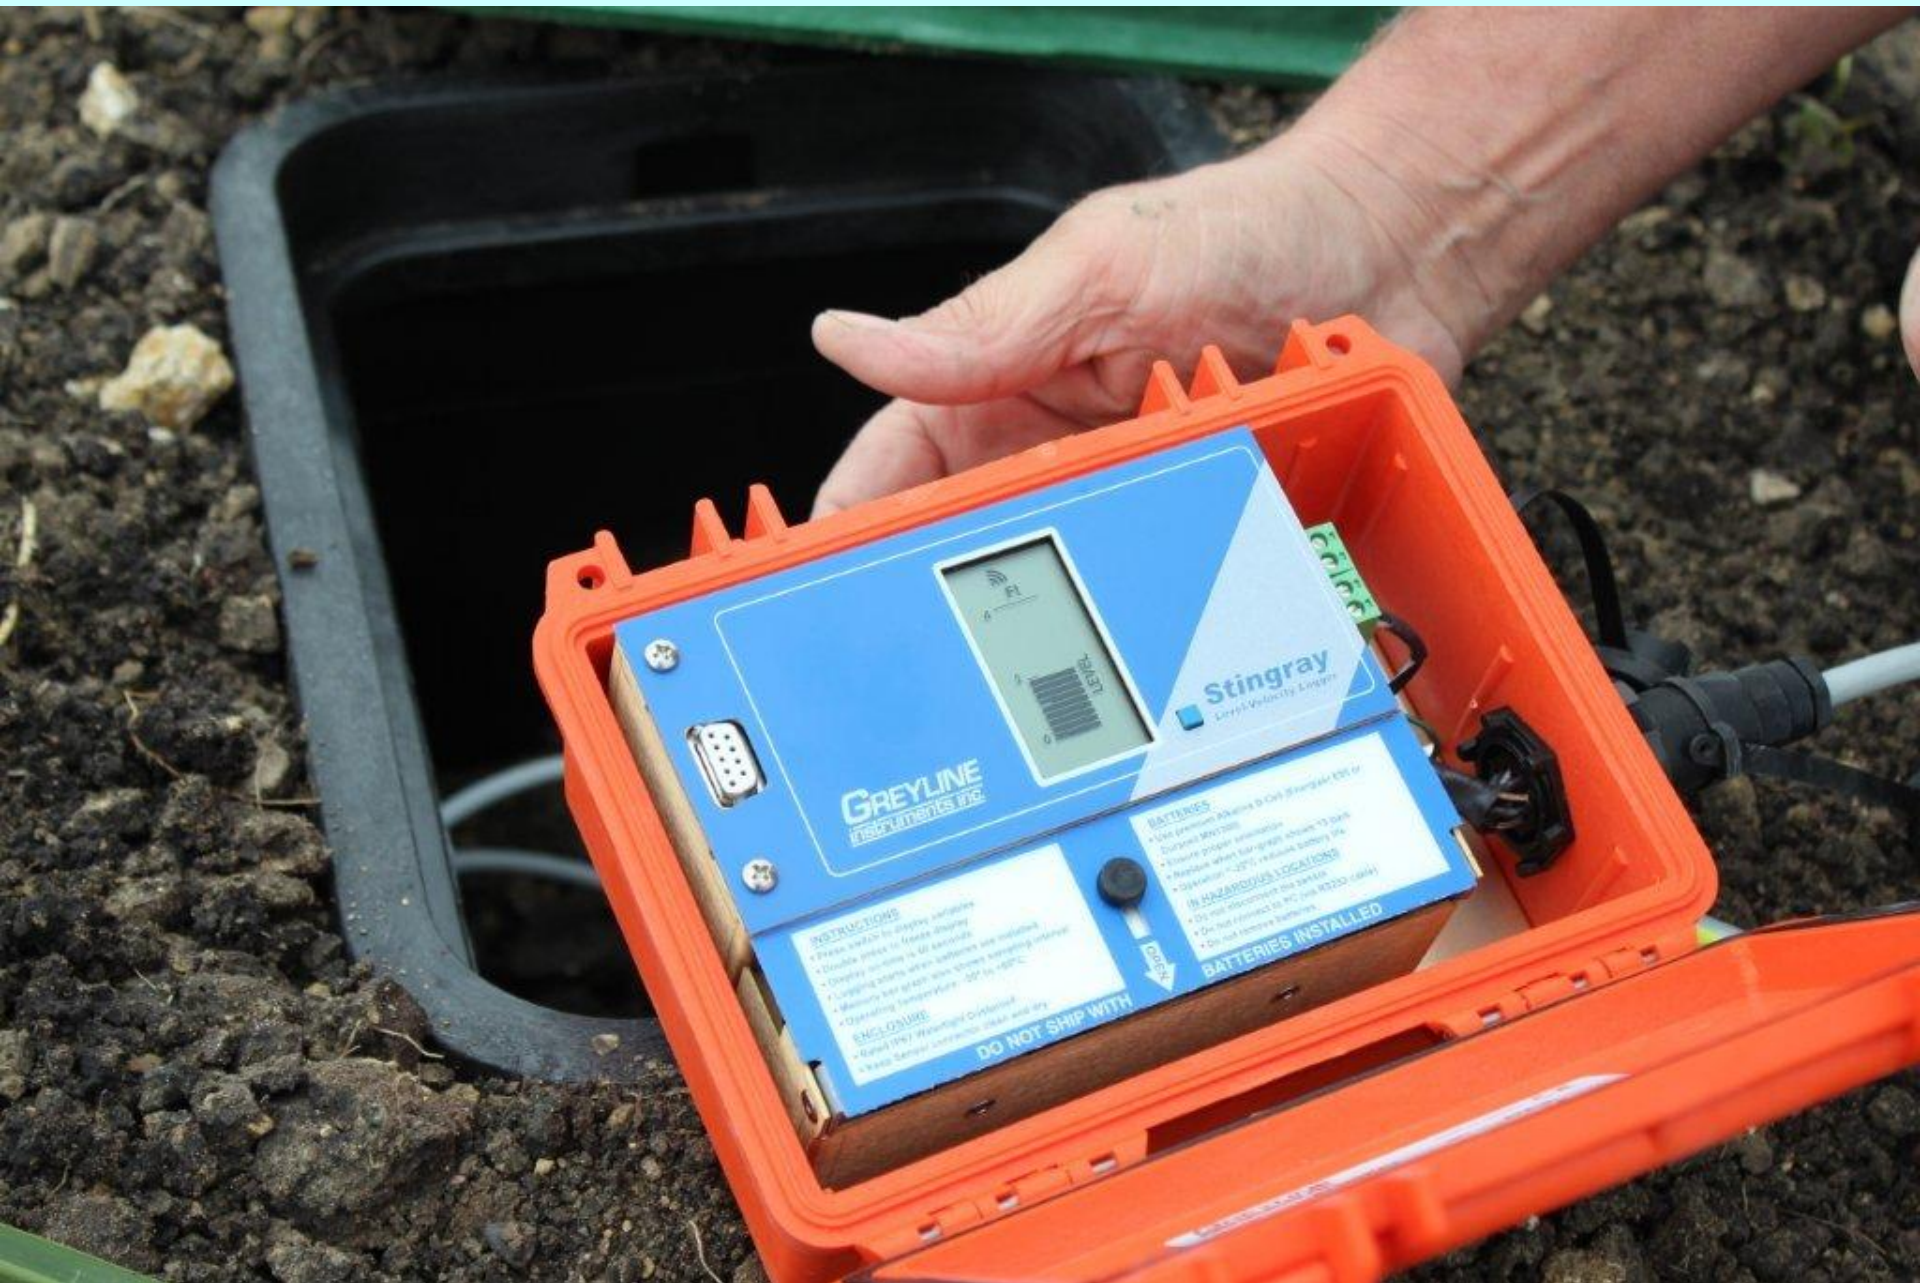
HOBO® Datalogger

Split-Core Current Switch

Stingray
Level Velocity Logger

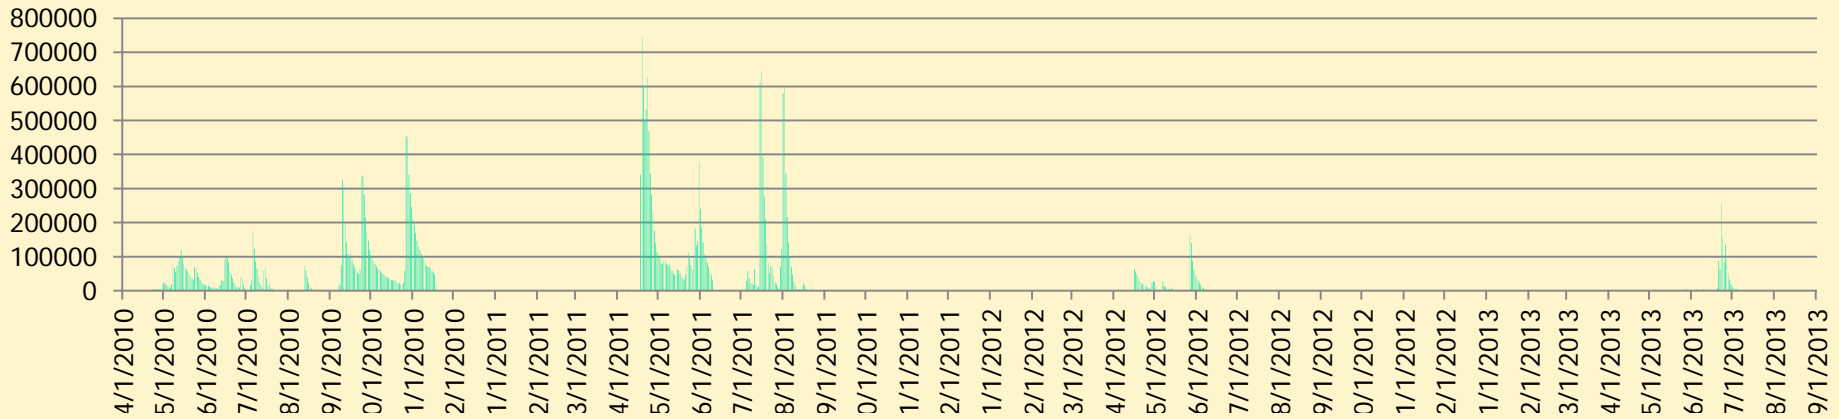
Pumped Volume (gallons)

Richland Site (2010 to 2013)

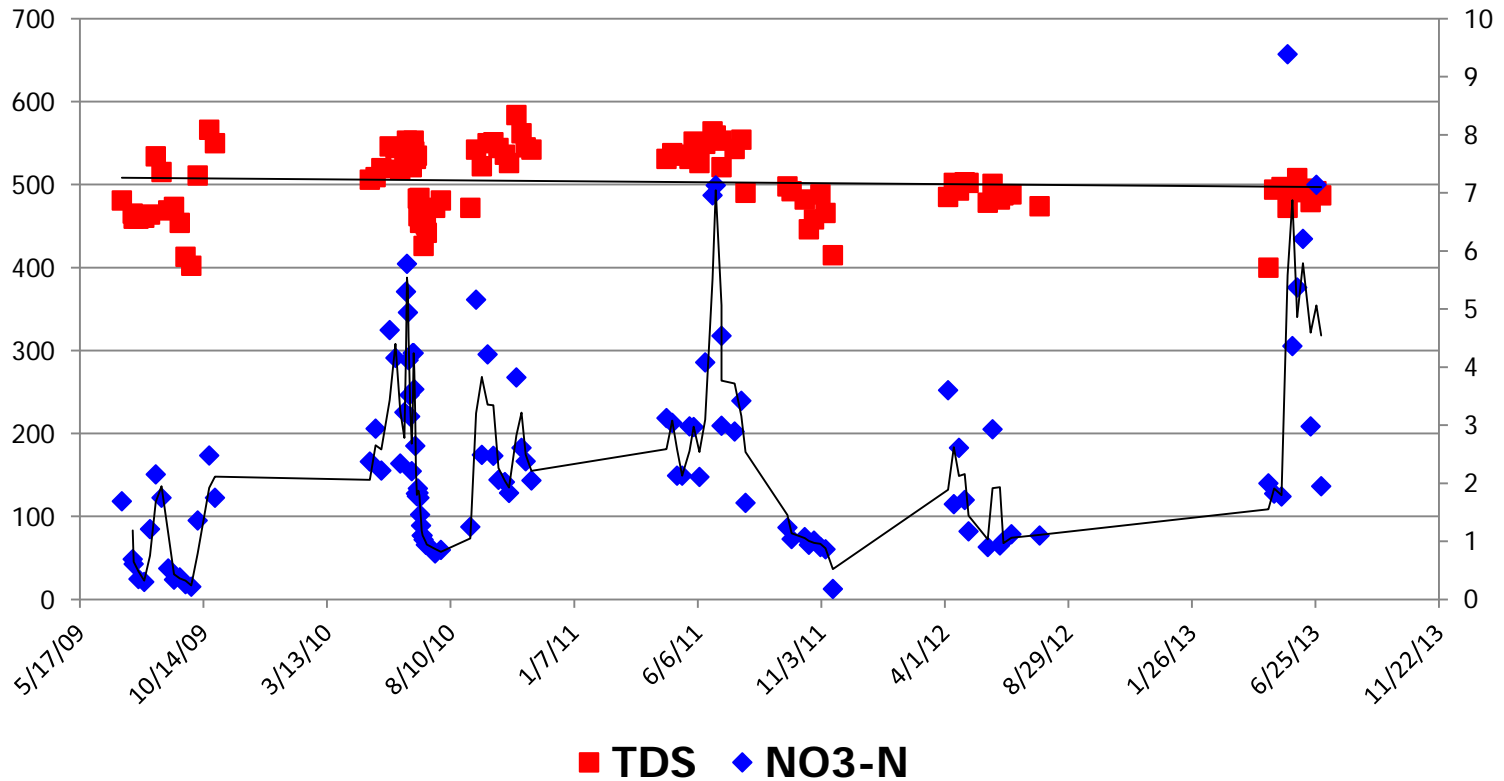
2009-2013 Grand Forks County TDS and Nitrate-Nitrogen

Grand Forks County - Wyndmere/Tiffany Fine Sandy Loam

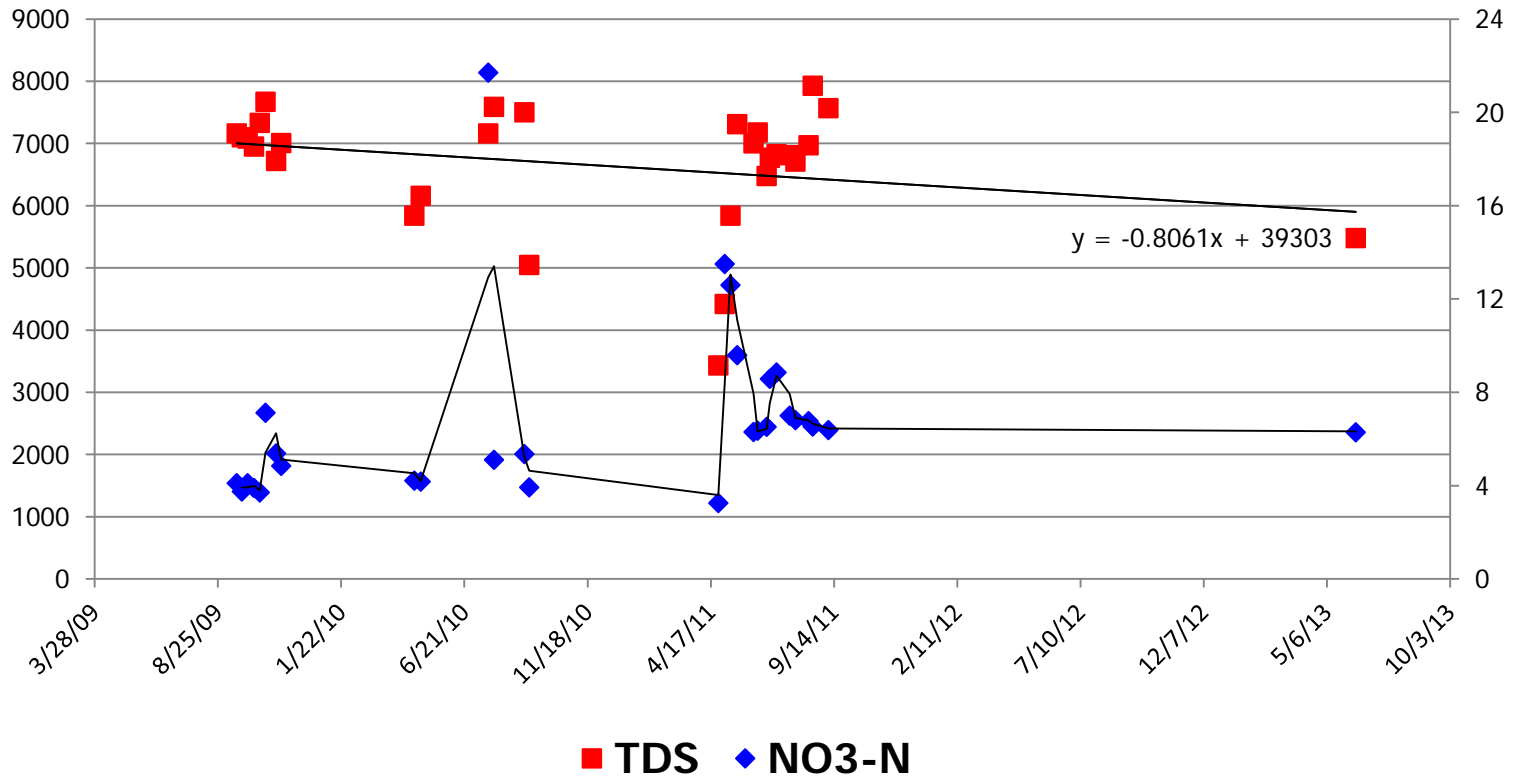
2009-2013 Trail County TDS and Nitrate-Nitrogen

Trail County - Fargo Silty Clay

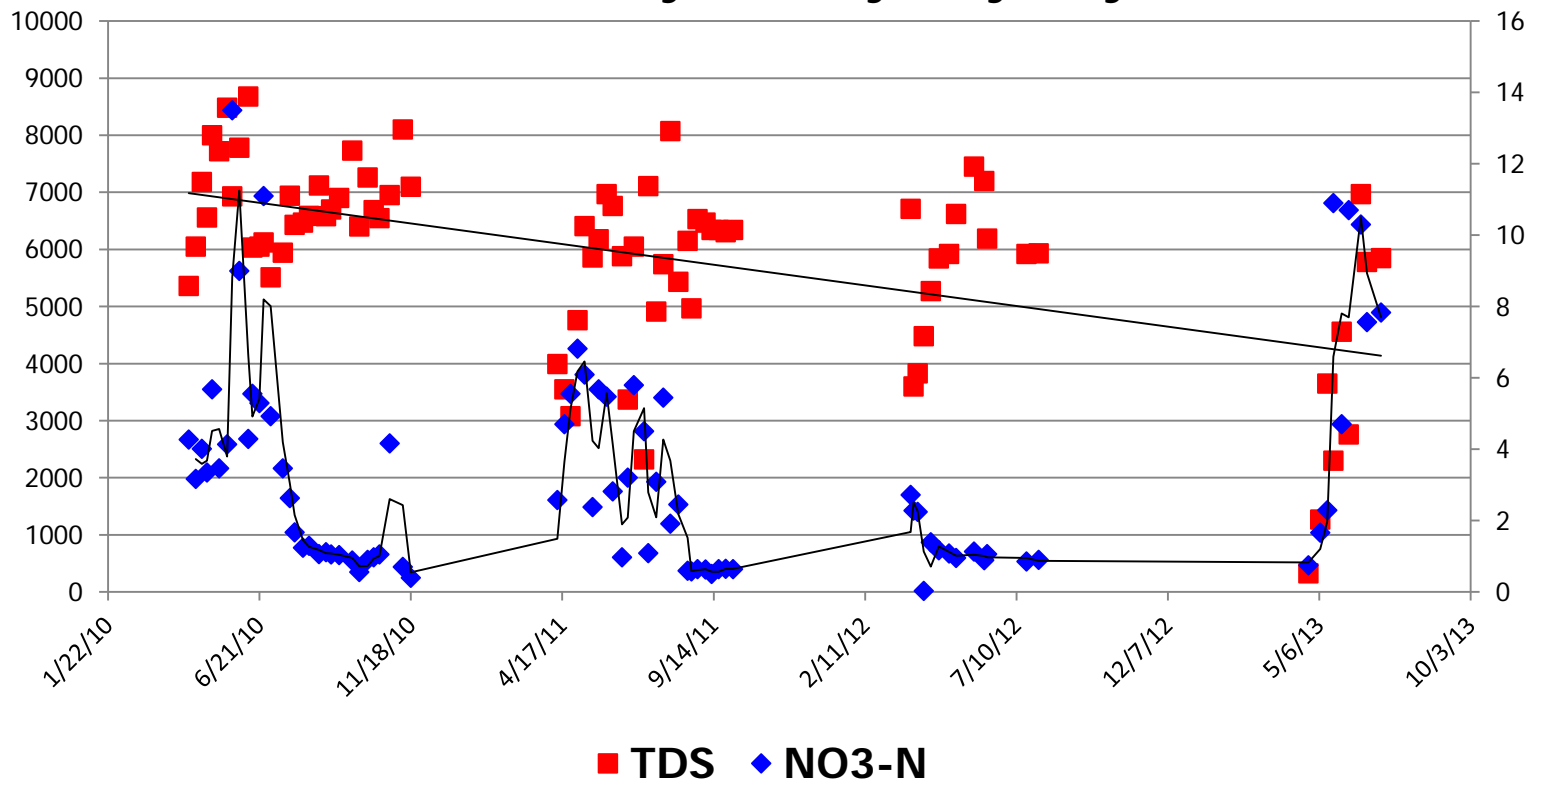
2009-2013 Walsh County TDS and Nitrate-Nitrogen

Walsh County - Overly Silty Clay Loam

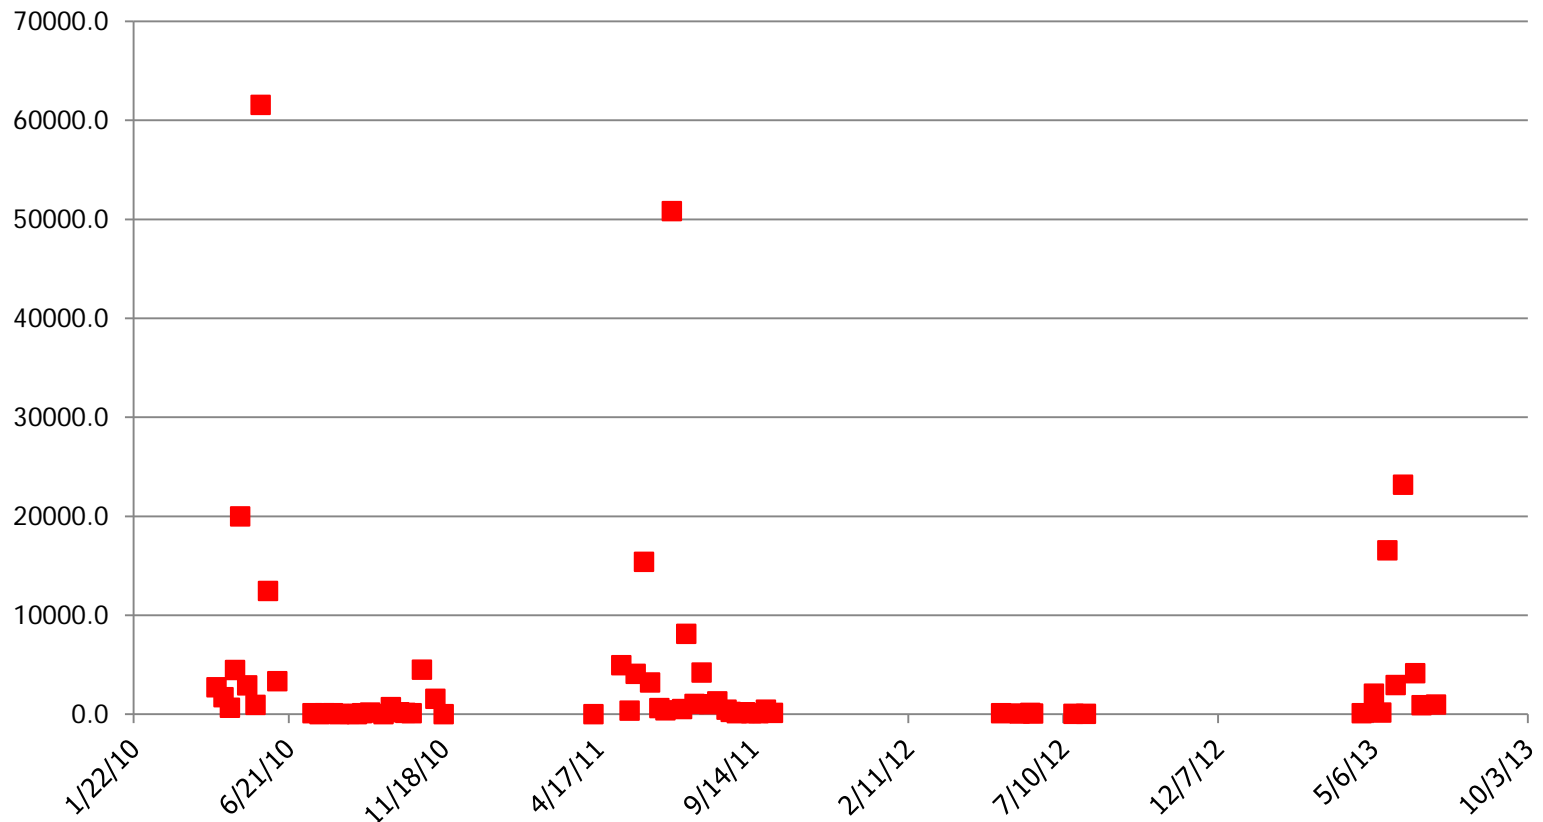
Walsh County - TDS Loading (lbs./day)

TDS Load at Tile Discharge

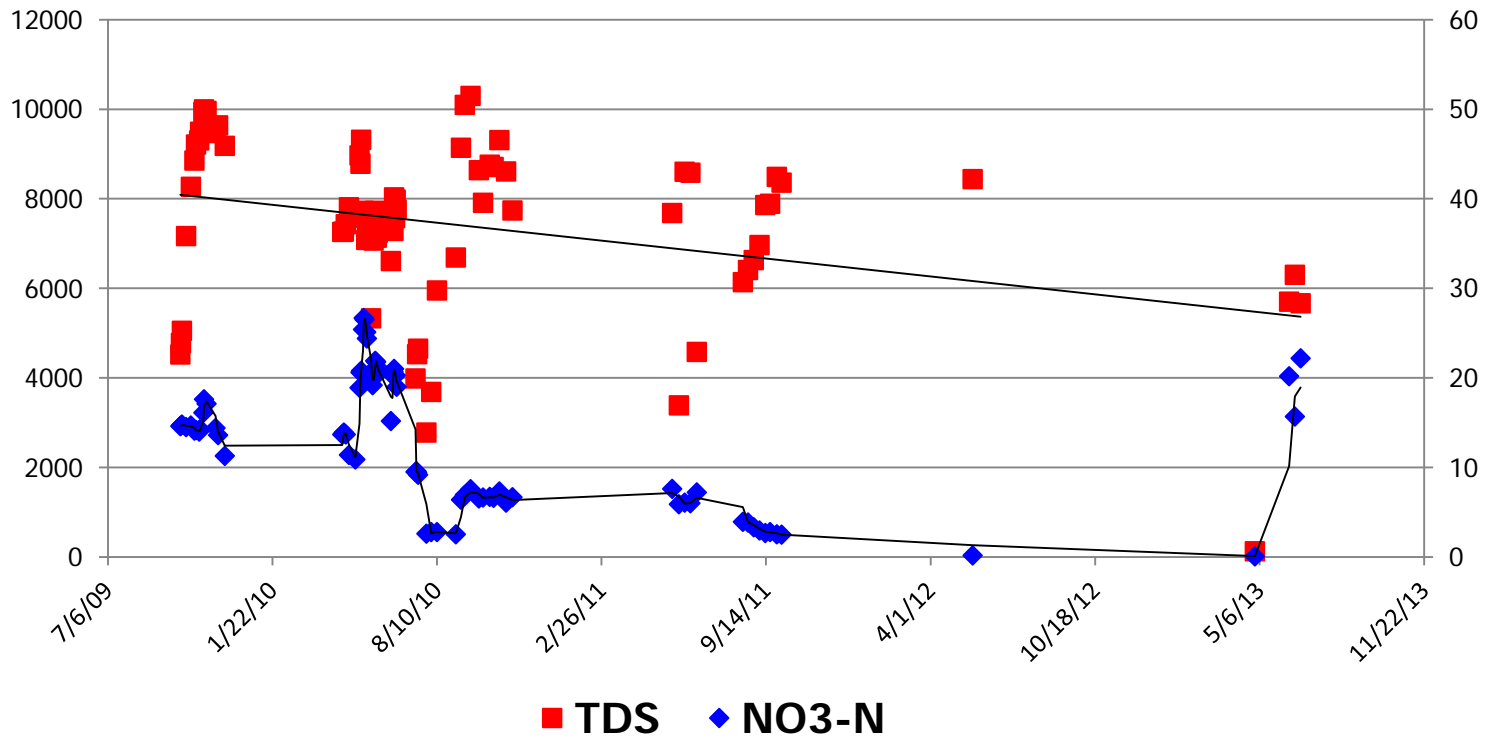
2009-2013 Cass County TDS and Nitrate-Nitrogen

Cass County - Fargo Silty Clay
