# English Coulee: Perspectives and Alternatives for Managing a Prairie Stream in an Urban Environment

Rachel Thorstenson, Environmental Restoration Student Club  
Phil Gerla, H. Hamm School of Geology and Geological Engineering

University of North Dakota

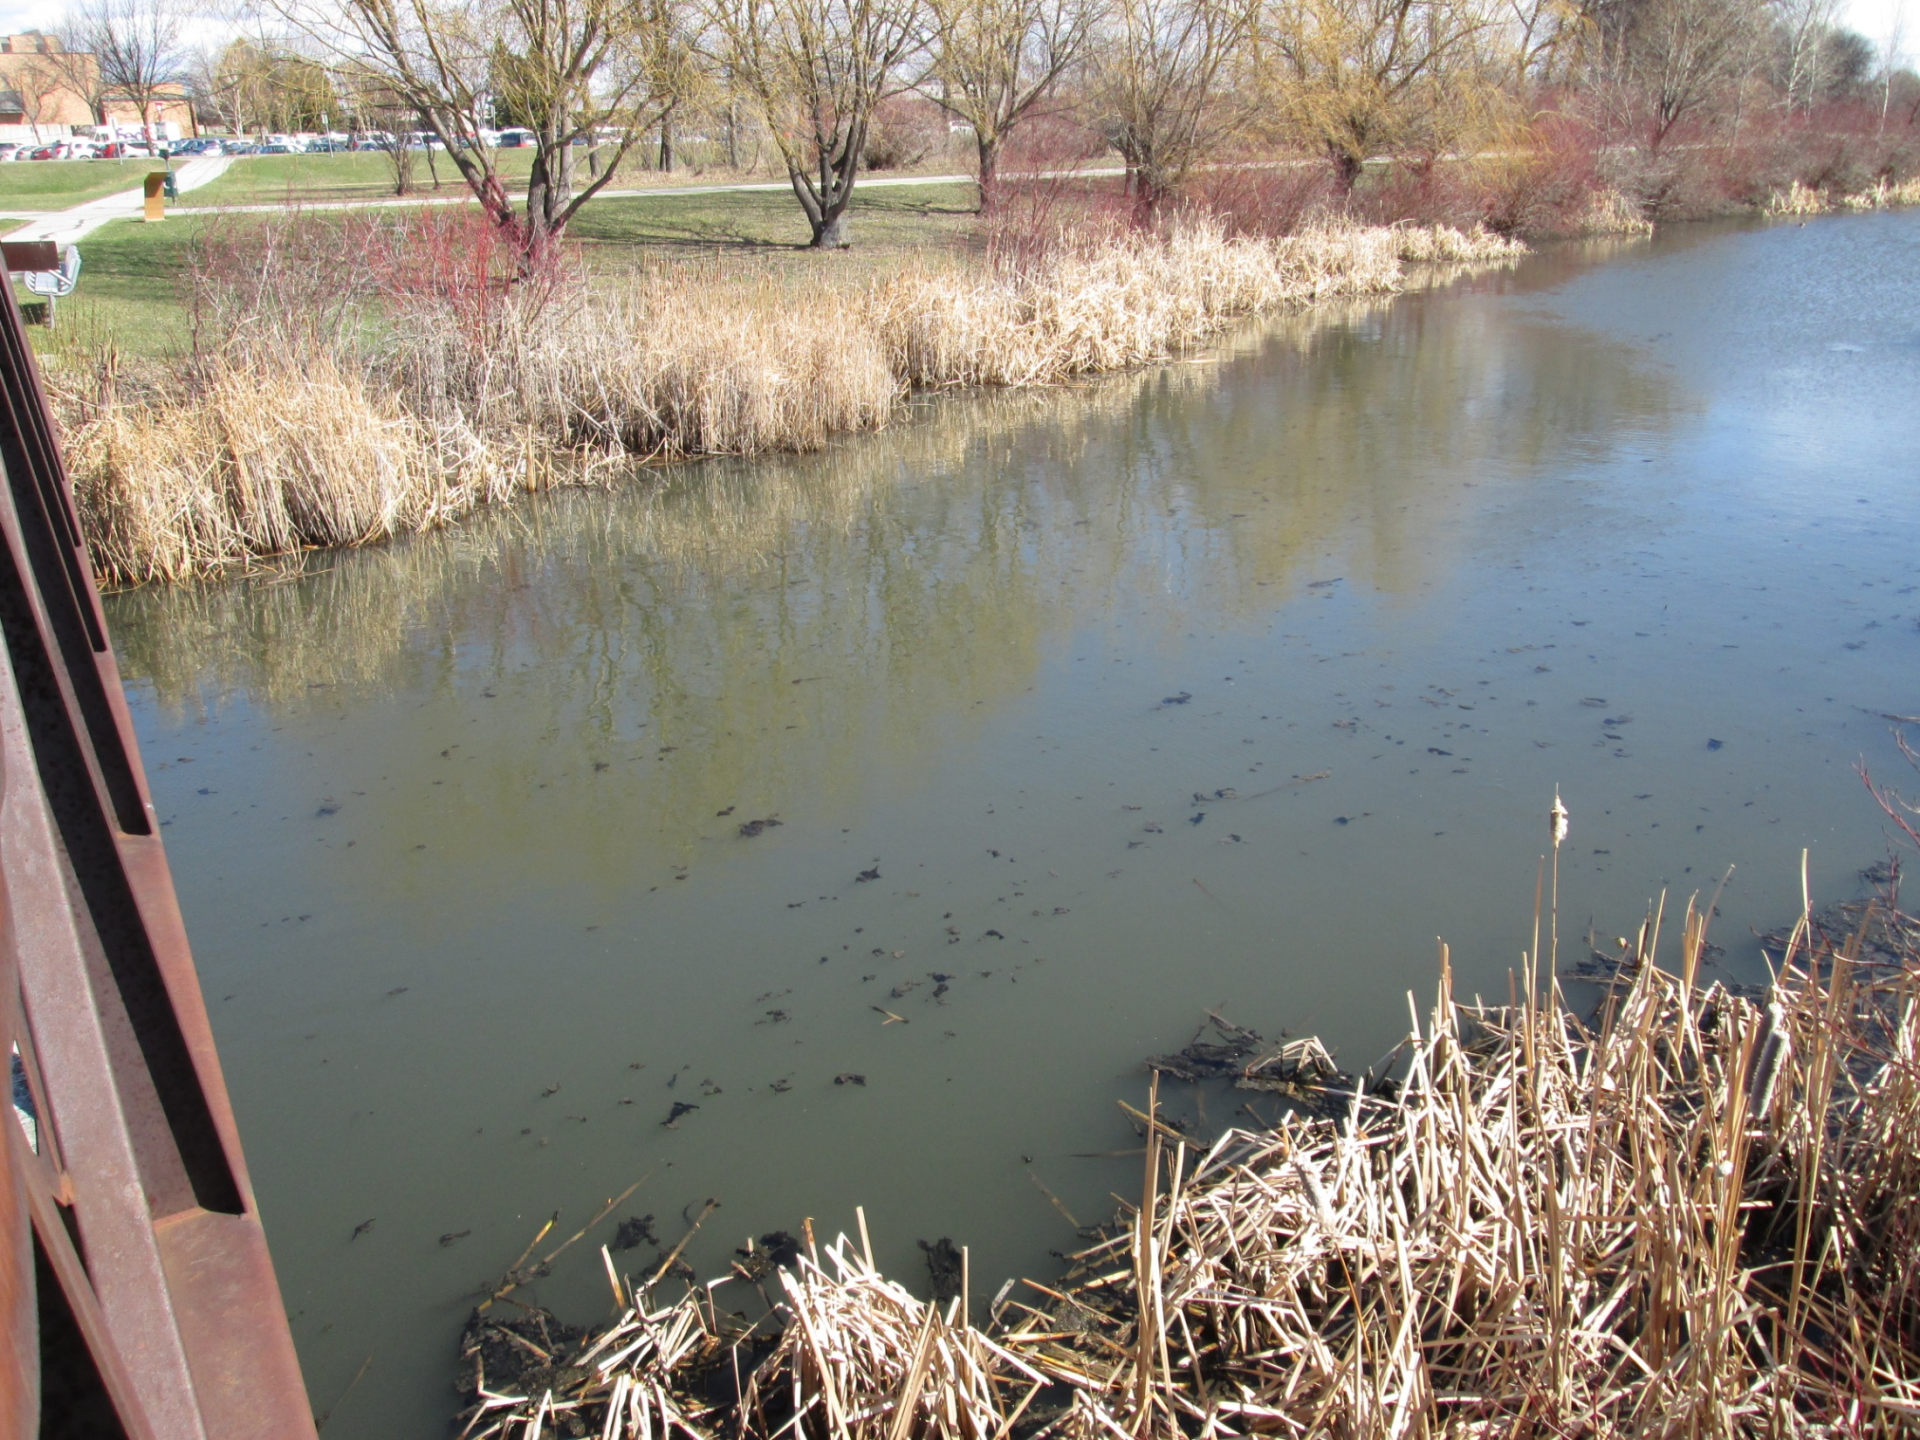
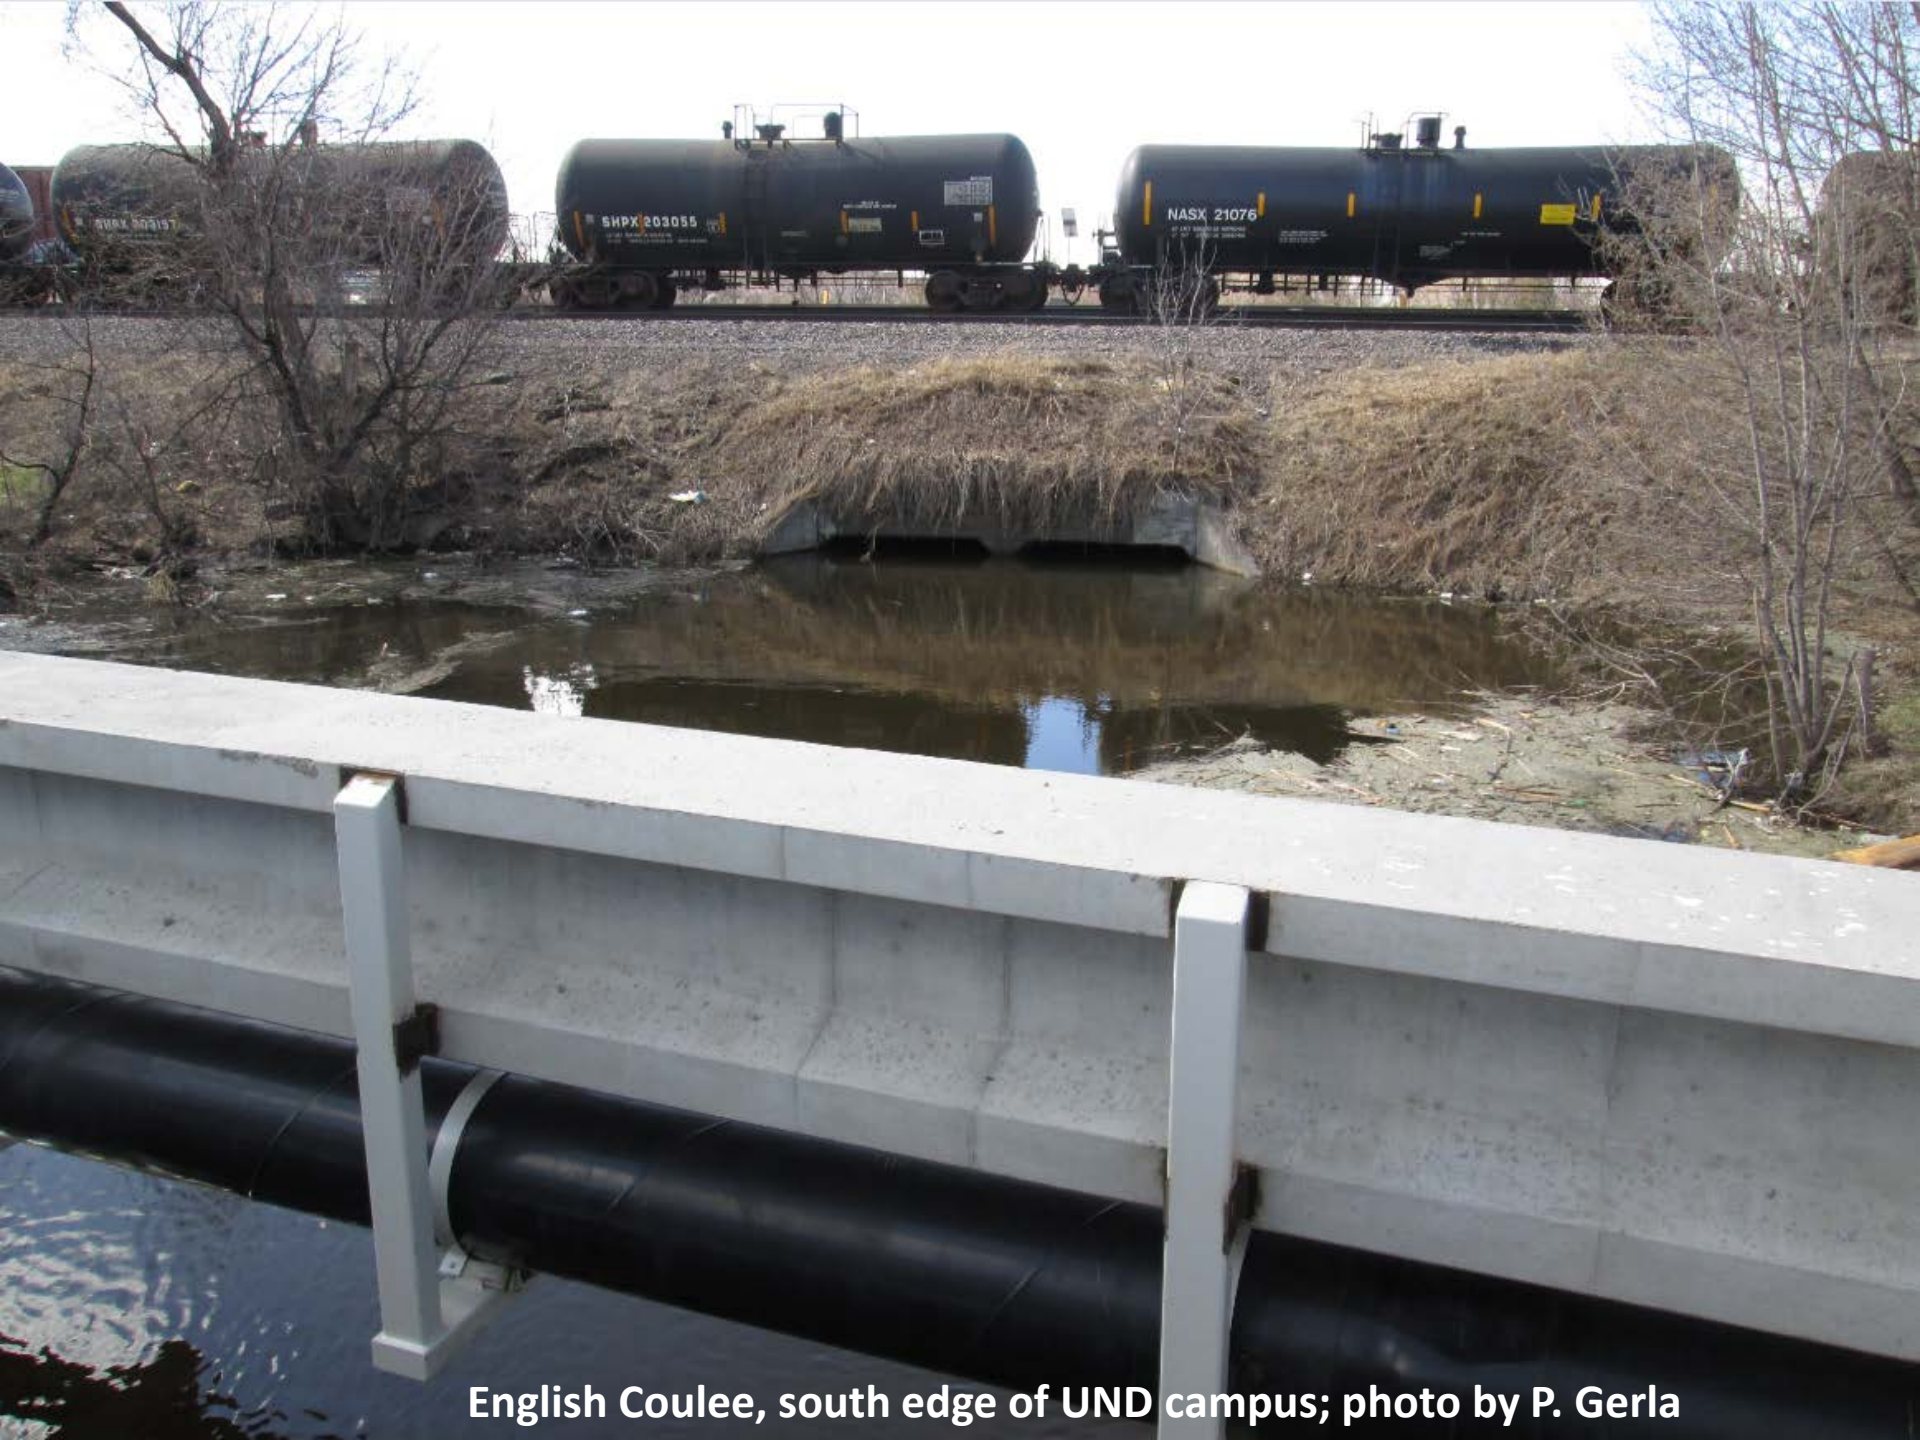
English Coulee, south edge of UND campus; photo by P. Gerla

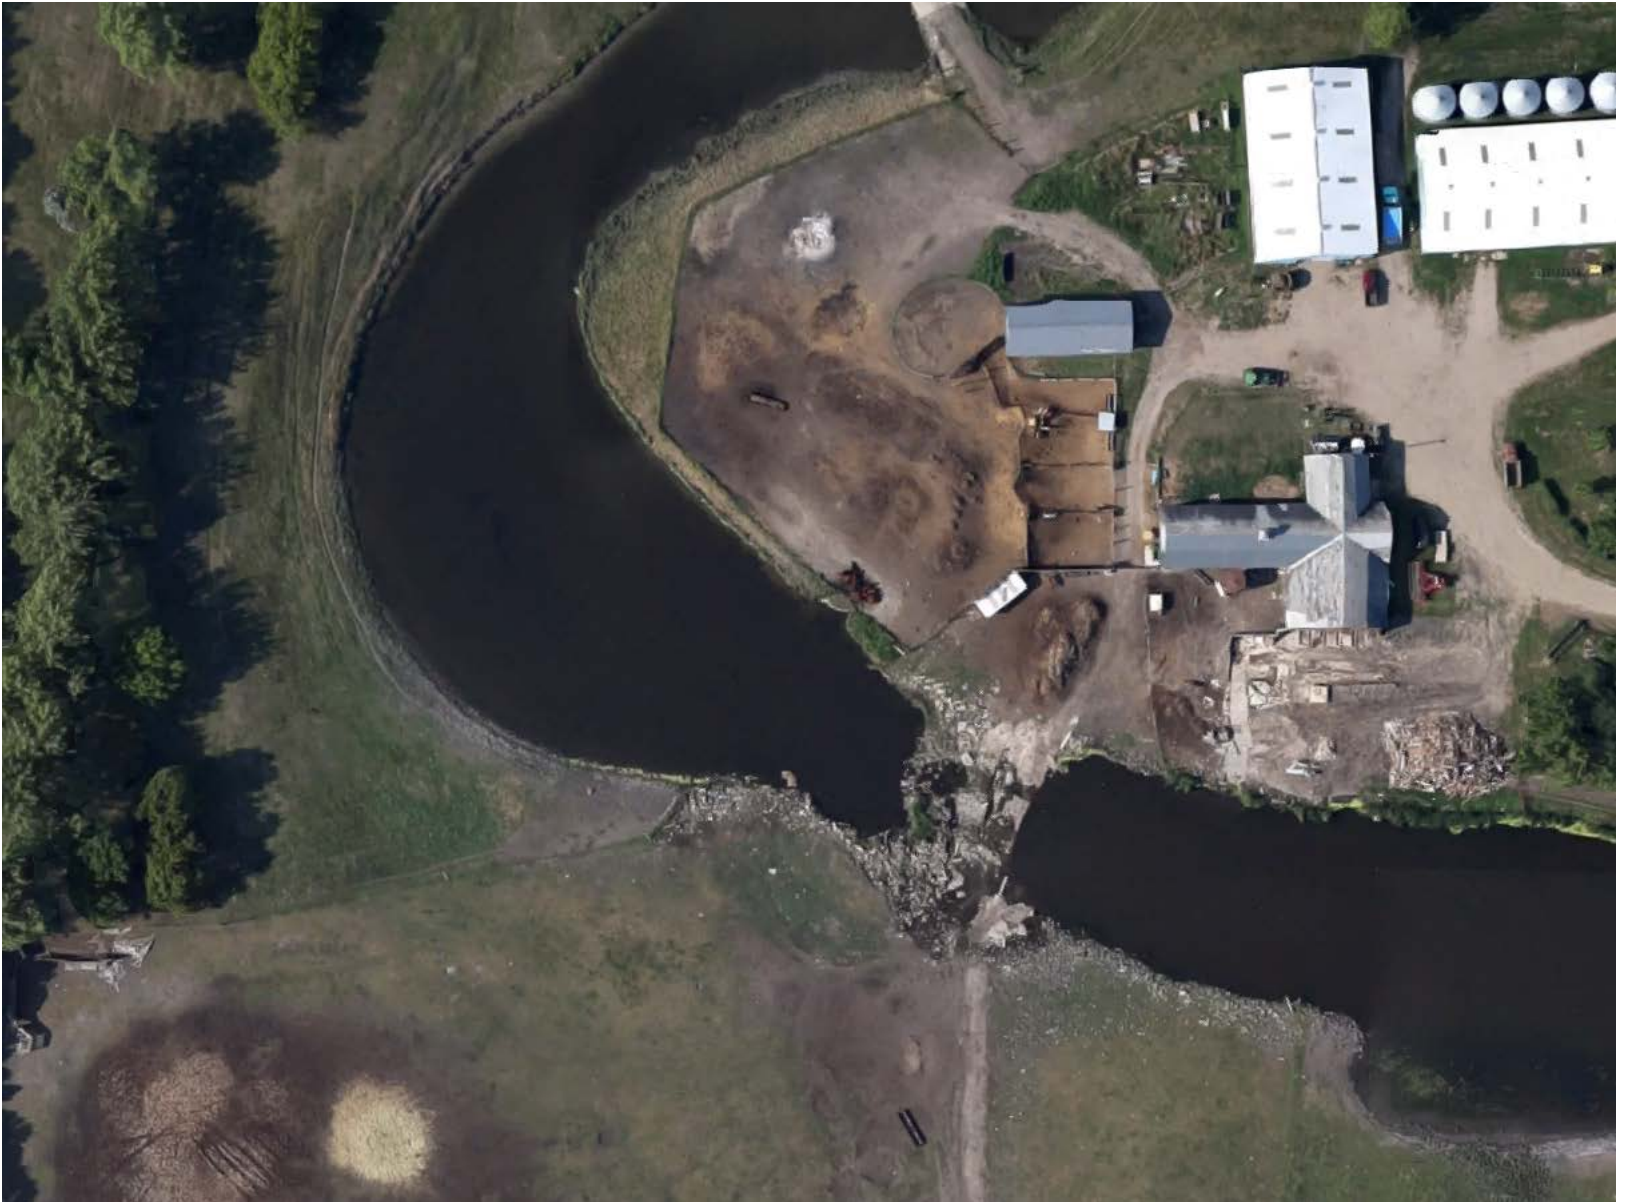
English Coulee and feedlot (near the intersection of Columbia Road and N. Washington St. (Google imagery))

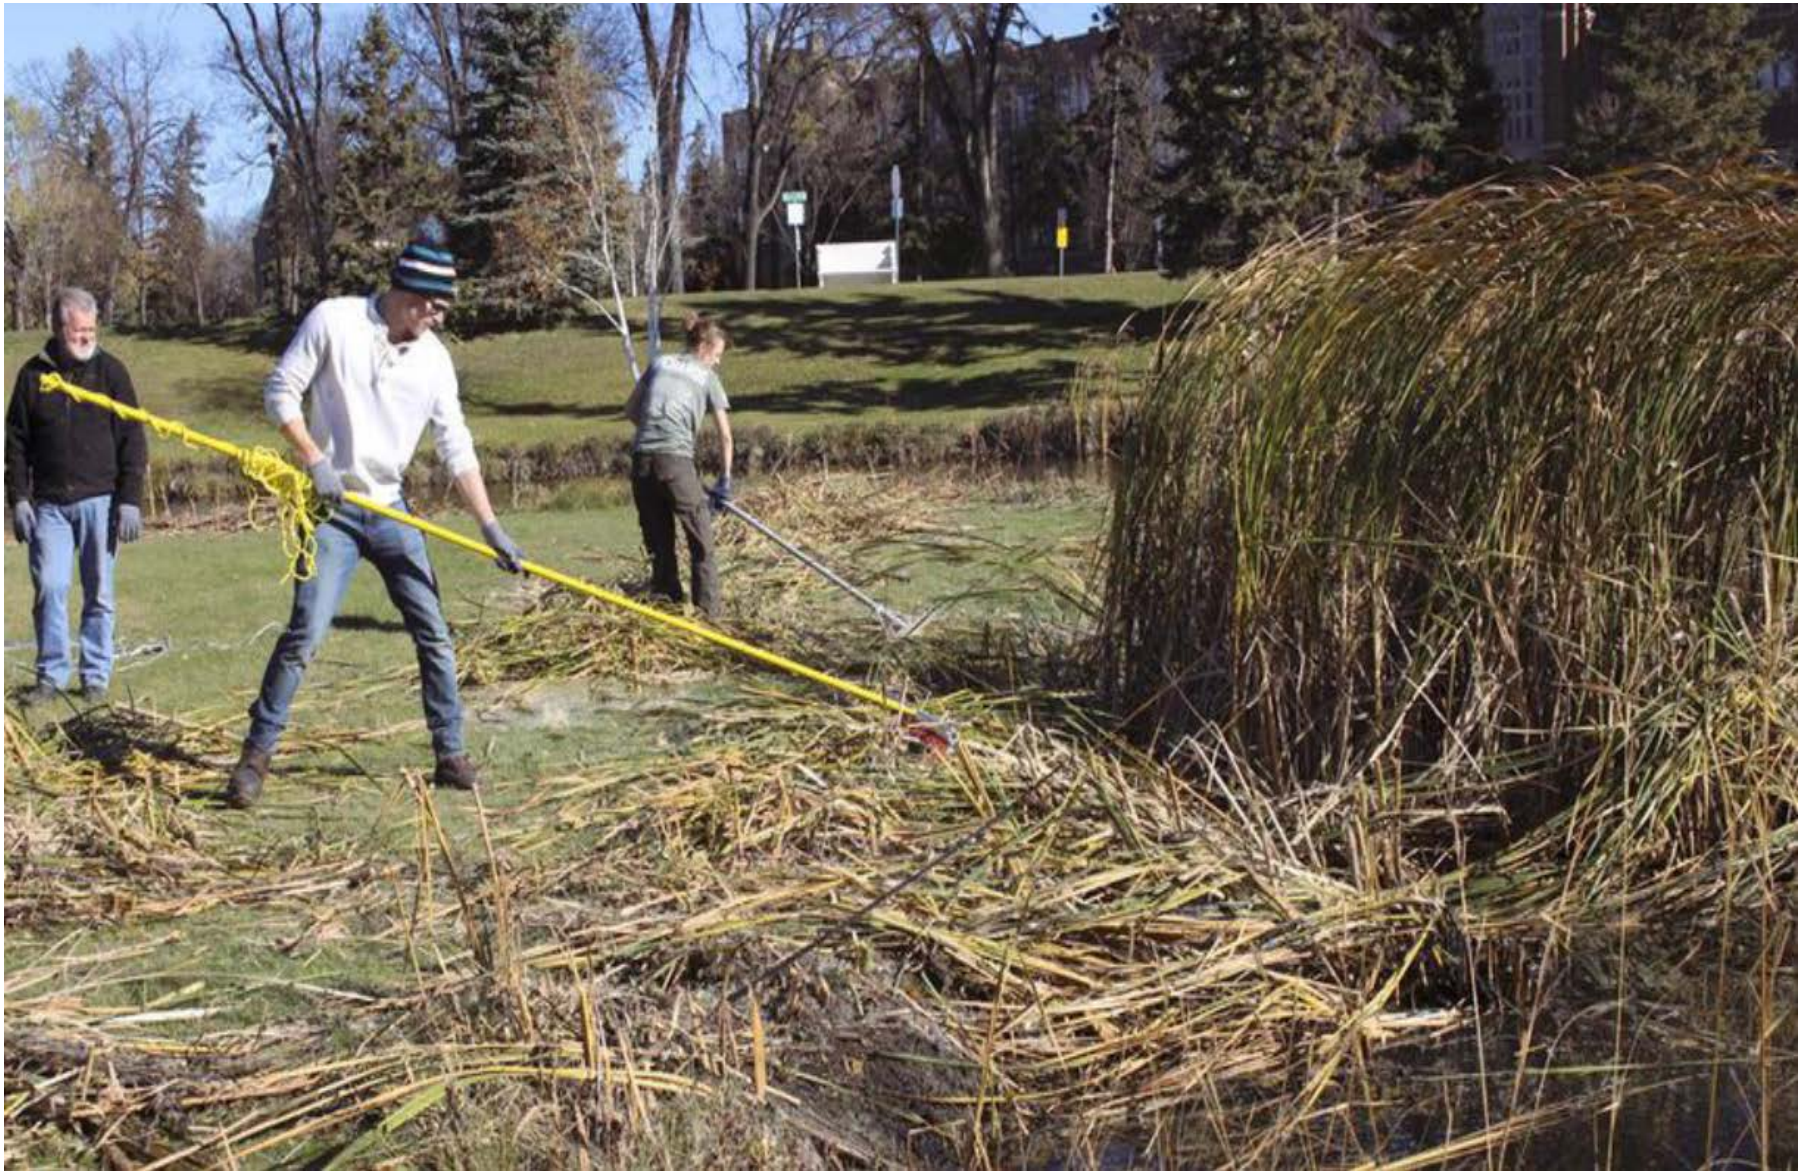
**excessive invasives --- photo by Kristine Lofgren**

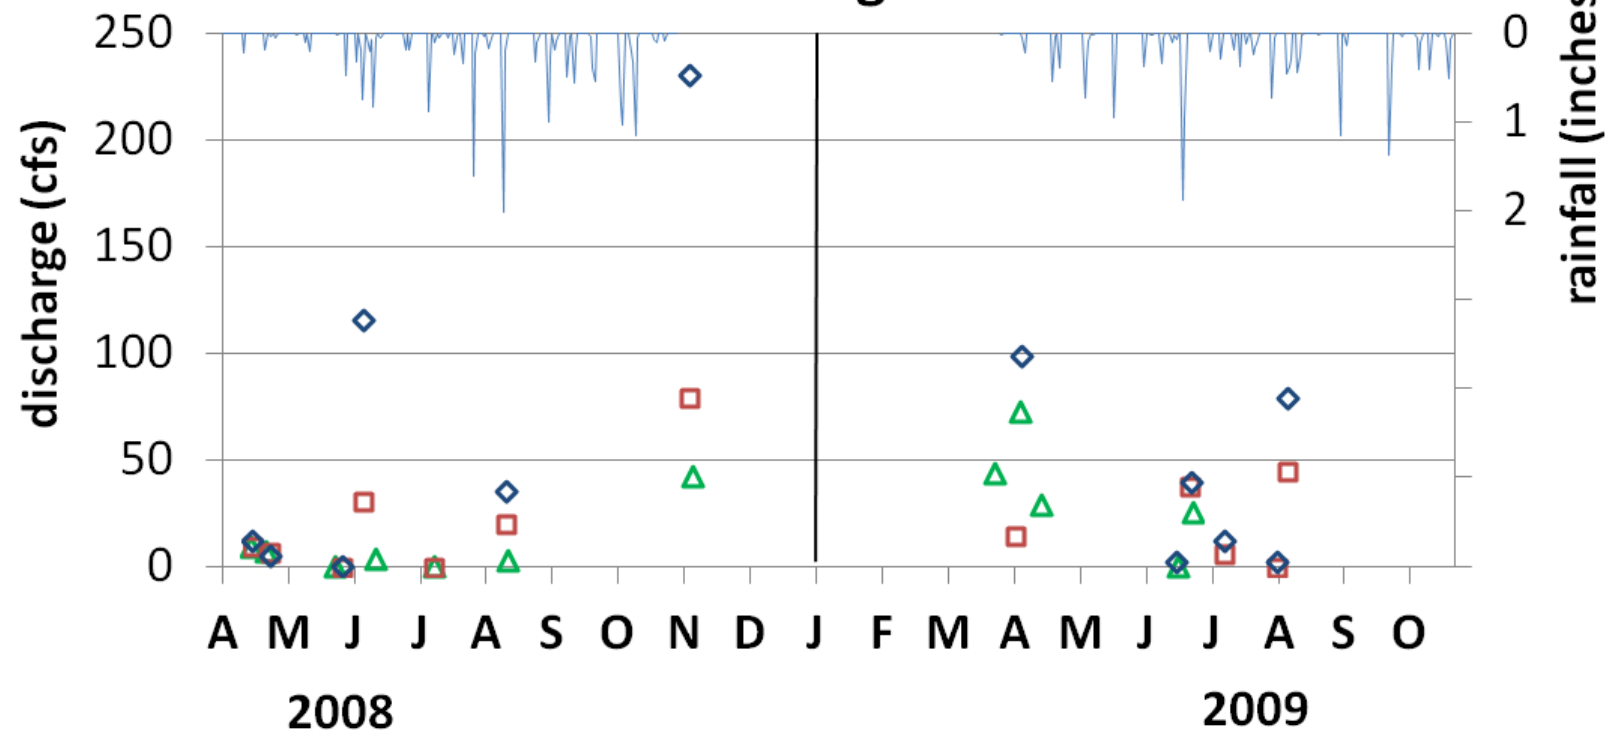
# stream discharge & rainfall

△ south    □ middle    ◇ north    — rainfall

rainfall data from the Grand Forks NDAWN station  
 stream discharge measurements – U.S. Geological Survey  
 and NWIS

## Some observations from 2008-2009 discharge and water-quality data

- Discharge & flashiness generally increased downstream, due to storm runoff
- *E. coli* measurements suggest contamination throughout the reach
- *E. coli* consistently fell well above recreational standards (geometric mean of 5 samples over a 30-day period is required to be less than 125 CFU/100 mL, with no sample testing higher than 235 CFU/100 mL (U.S. EPA))
- Total N varied between 1 - 2 mg/L, mean total phosphorus roughly 0.2 mg/L
- Greatest nutrient concentrations occurred during the summer (late in 2009, ditch clean-outs led to elevated concentrations)
- TDS varied an order of magnitude within a few weeks time (precipitation flushing?)

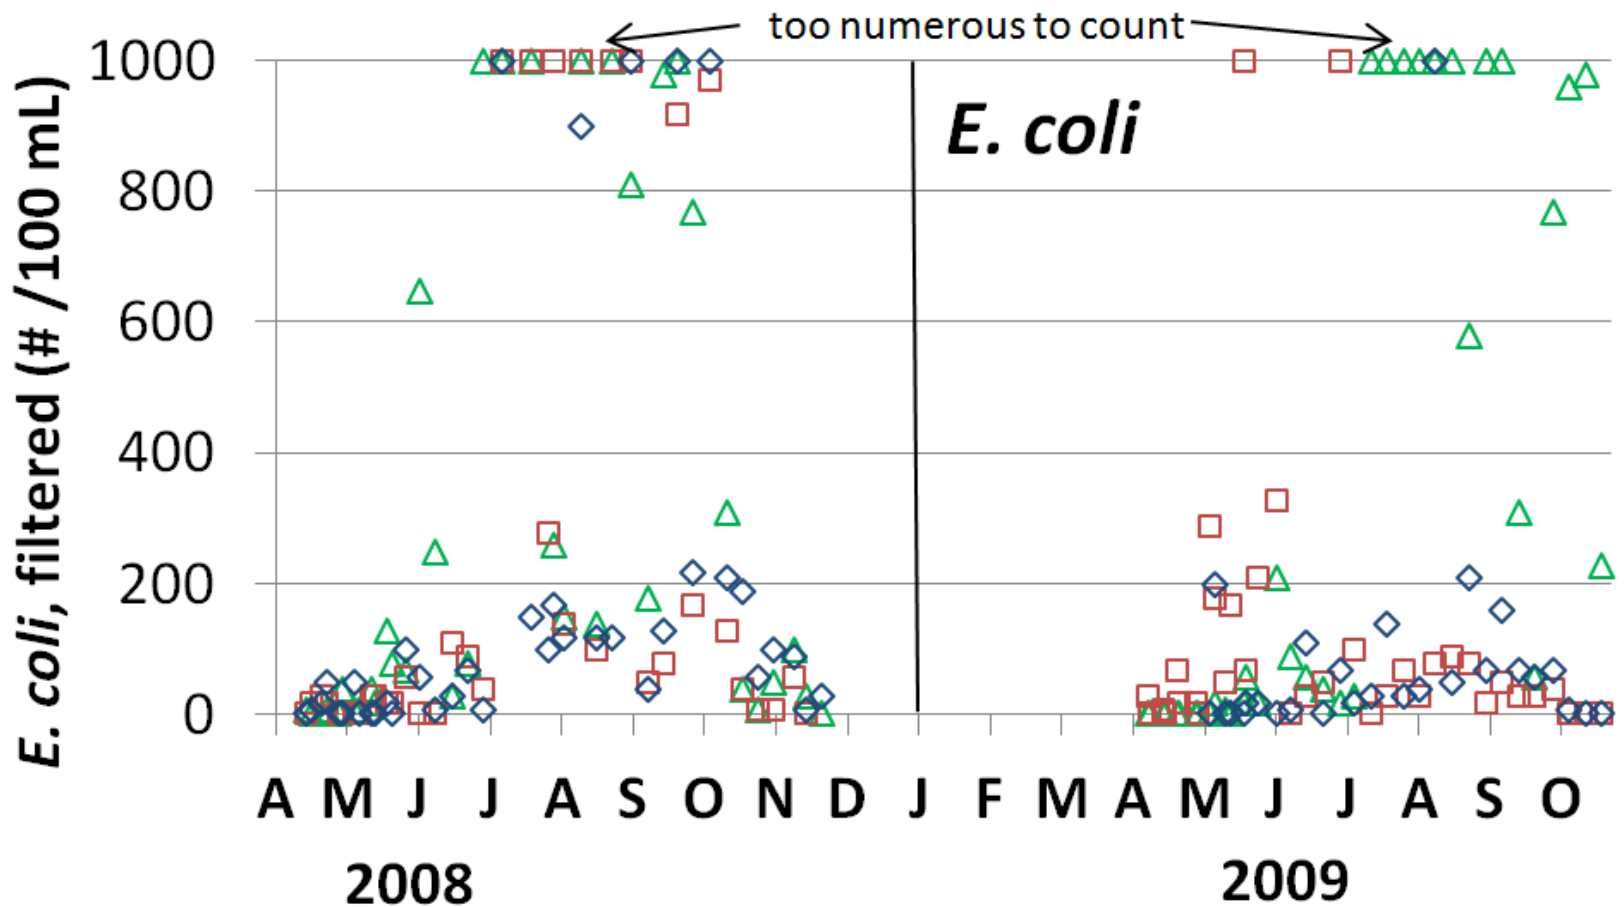
△ south   □ middle   ◇ north  
 data from the ND Department of Health

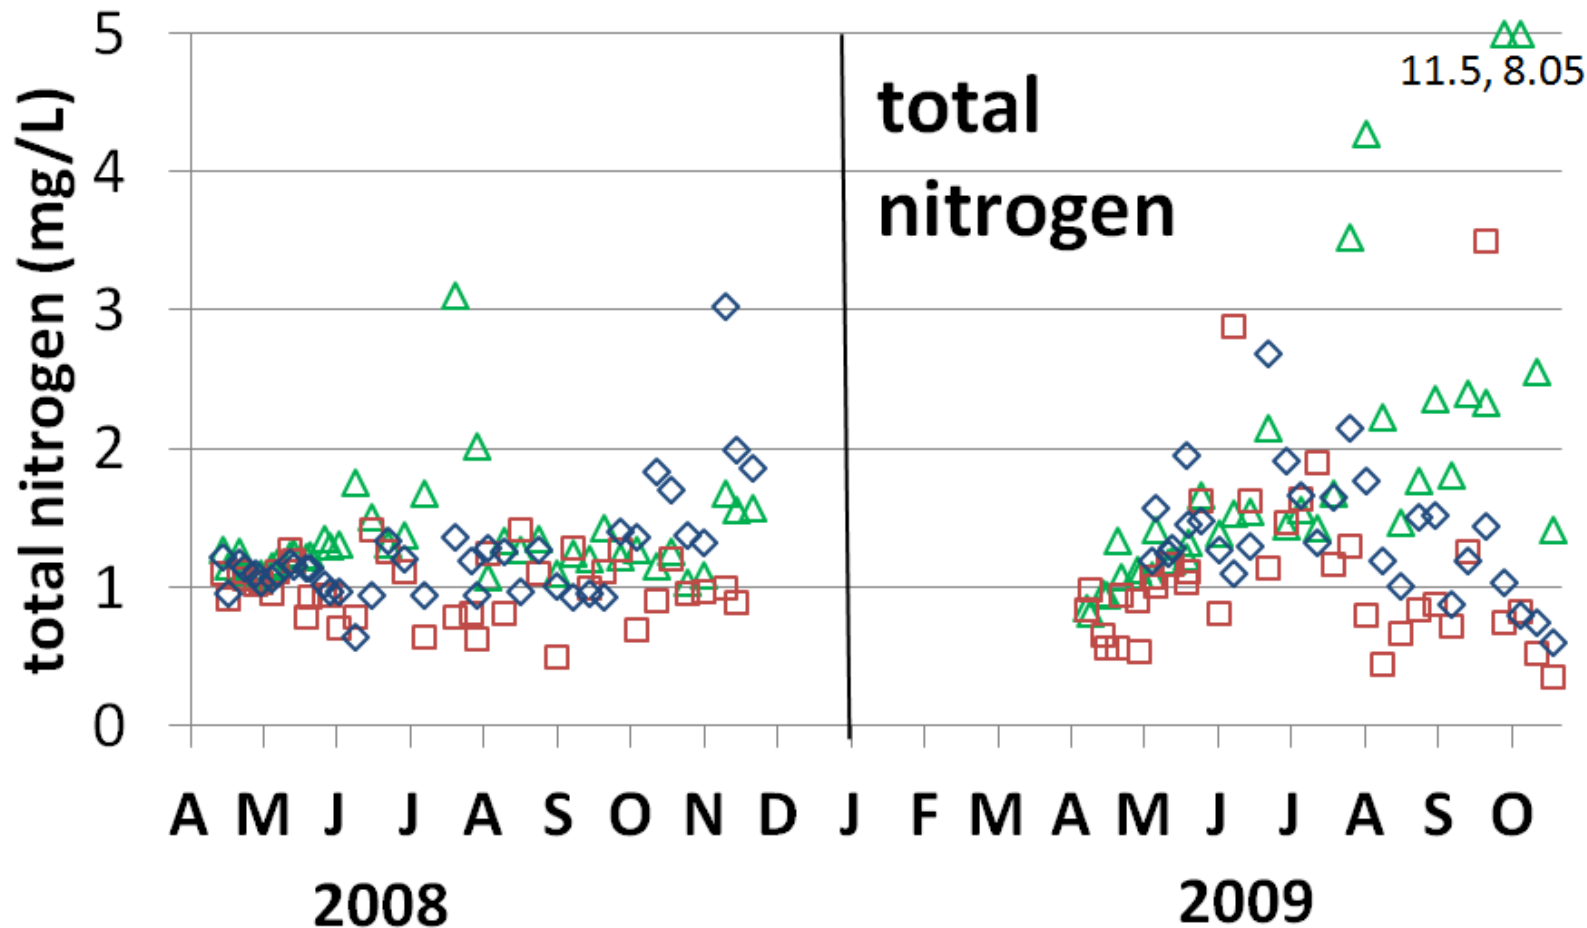
△ south    □ middle    ◇ north

data from the ND Department of Health

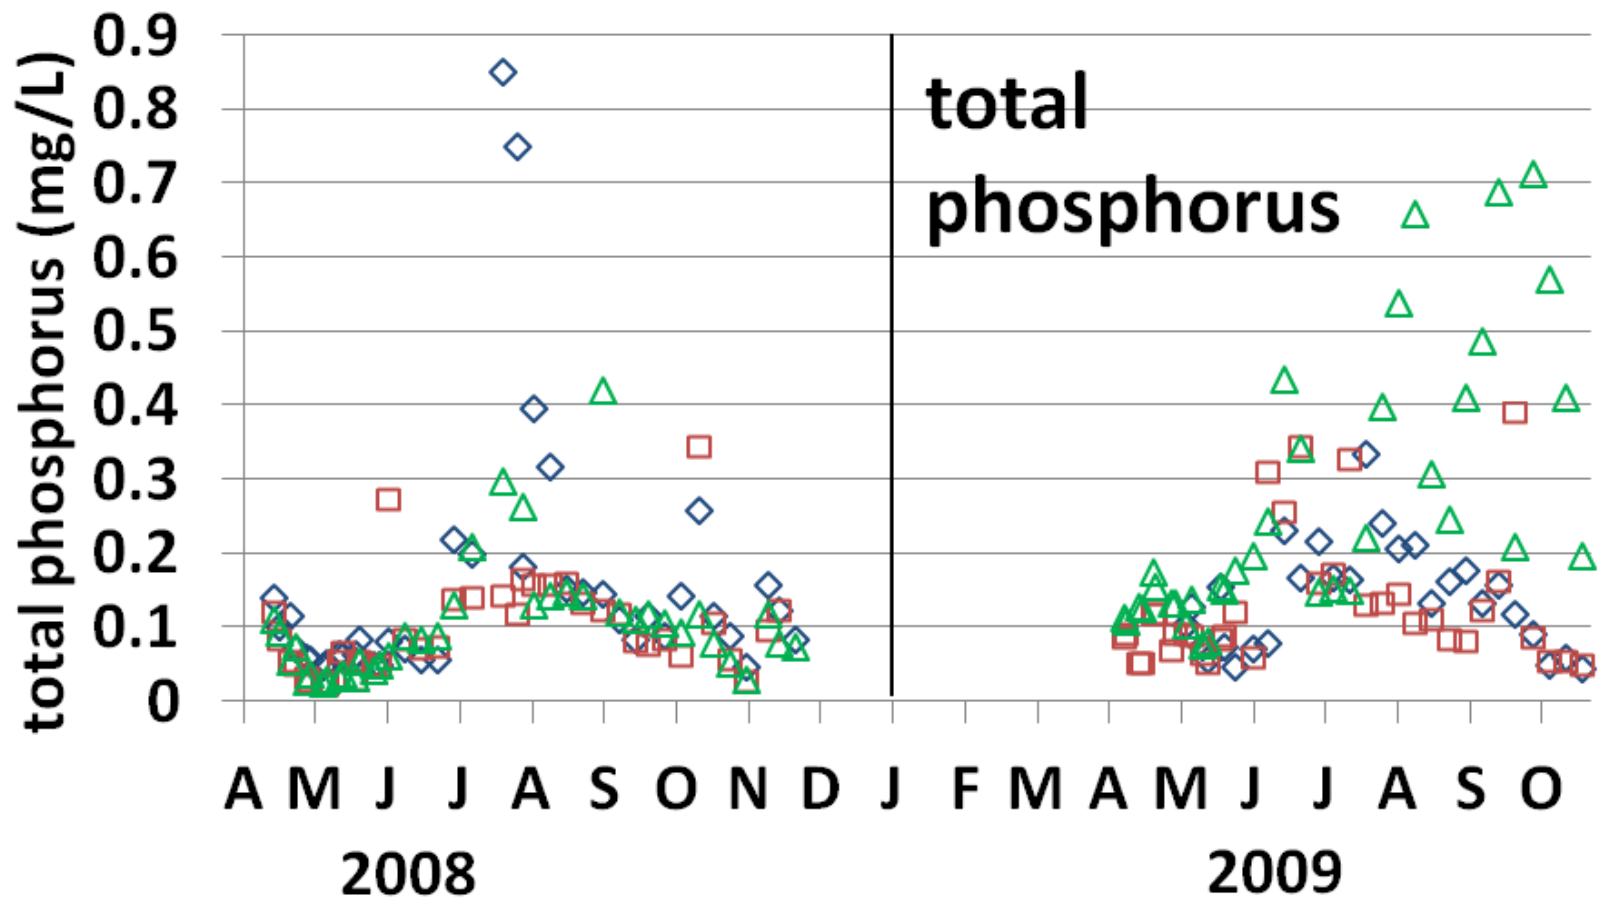
◇ north    □ middle    △ south

data from the ND Department of Health

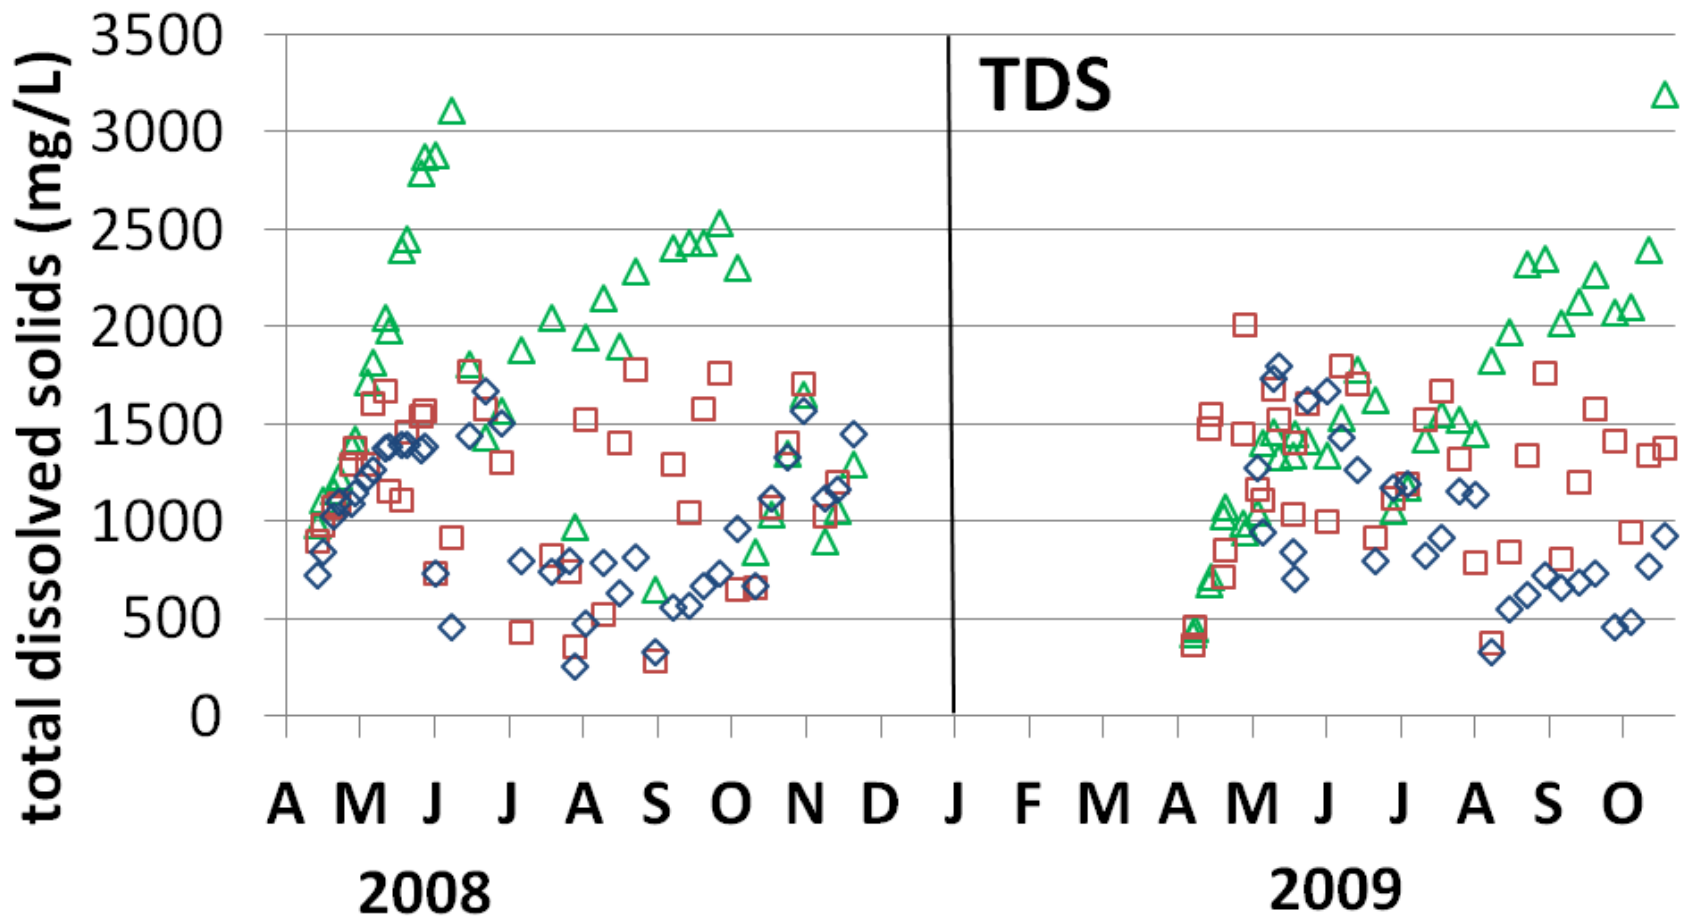
△ south    □ middle    ◇ north

data from the ND Department of Health

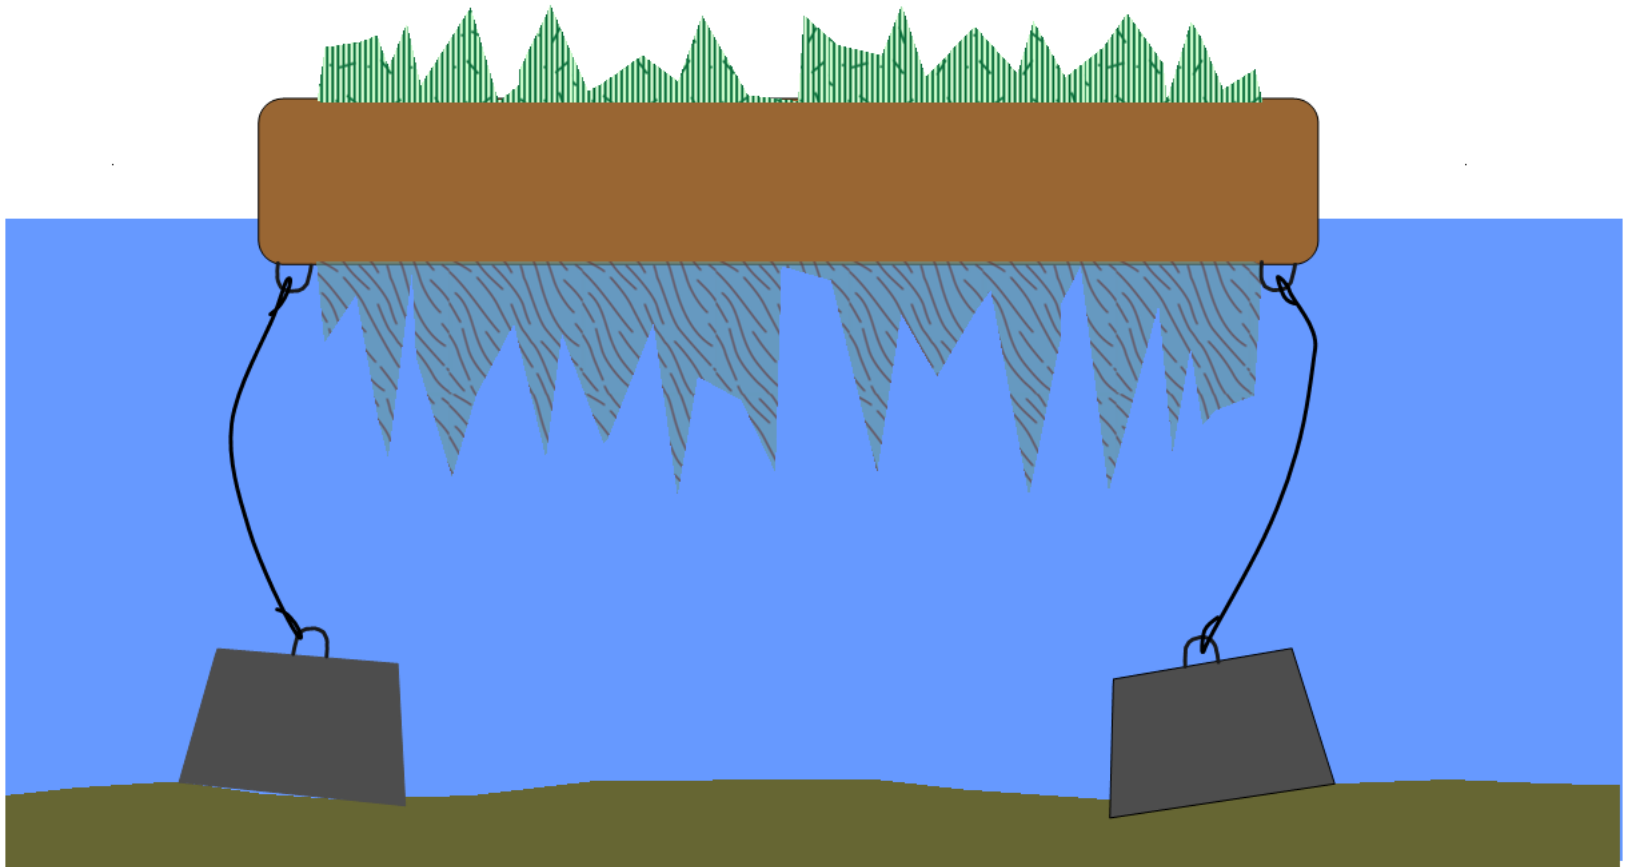
***Floating Wetland Gardens*** – the Environmental Restoration club's direction

image from <http://midwestfloatingisland.com/technology/>

**install 7 x 10 foot “islands” in wider, lower velocity parts of the waterway**

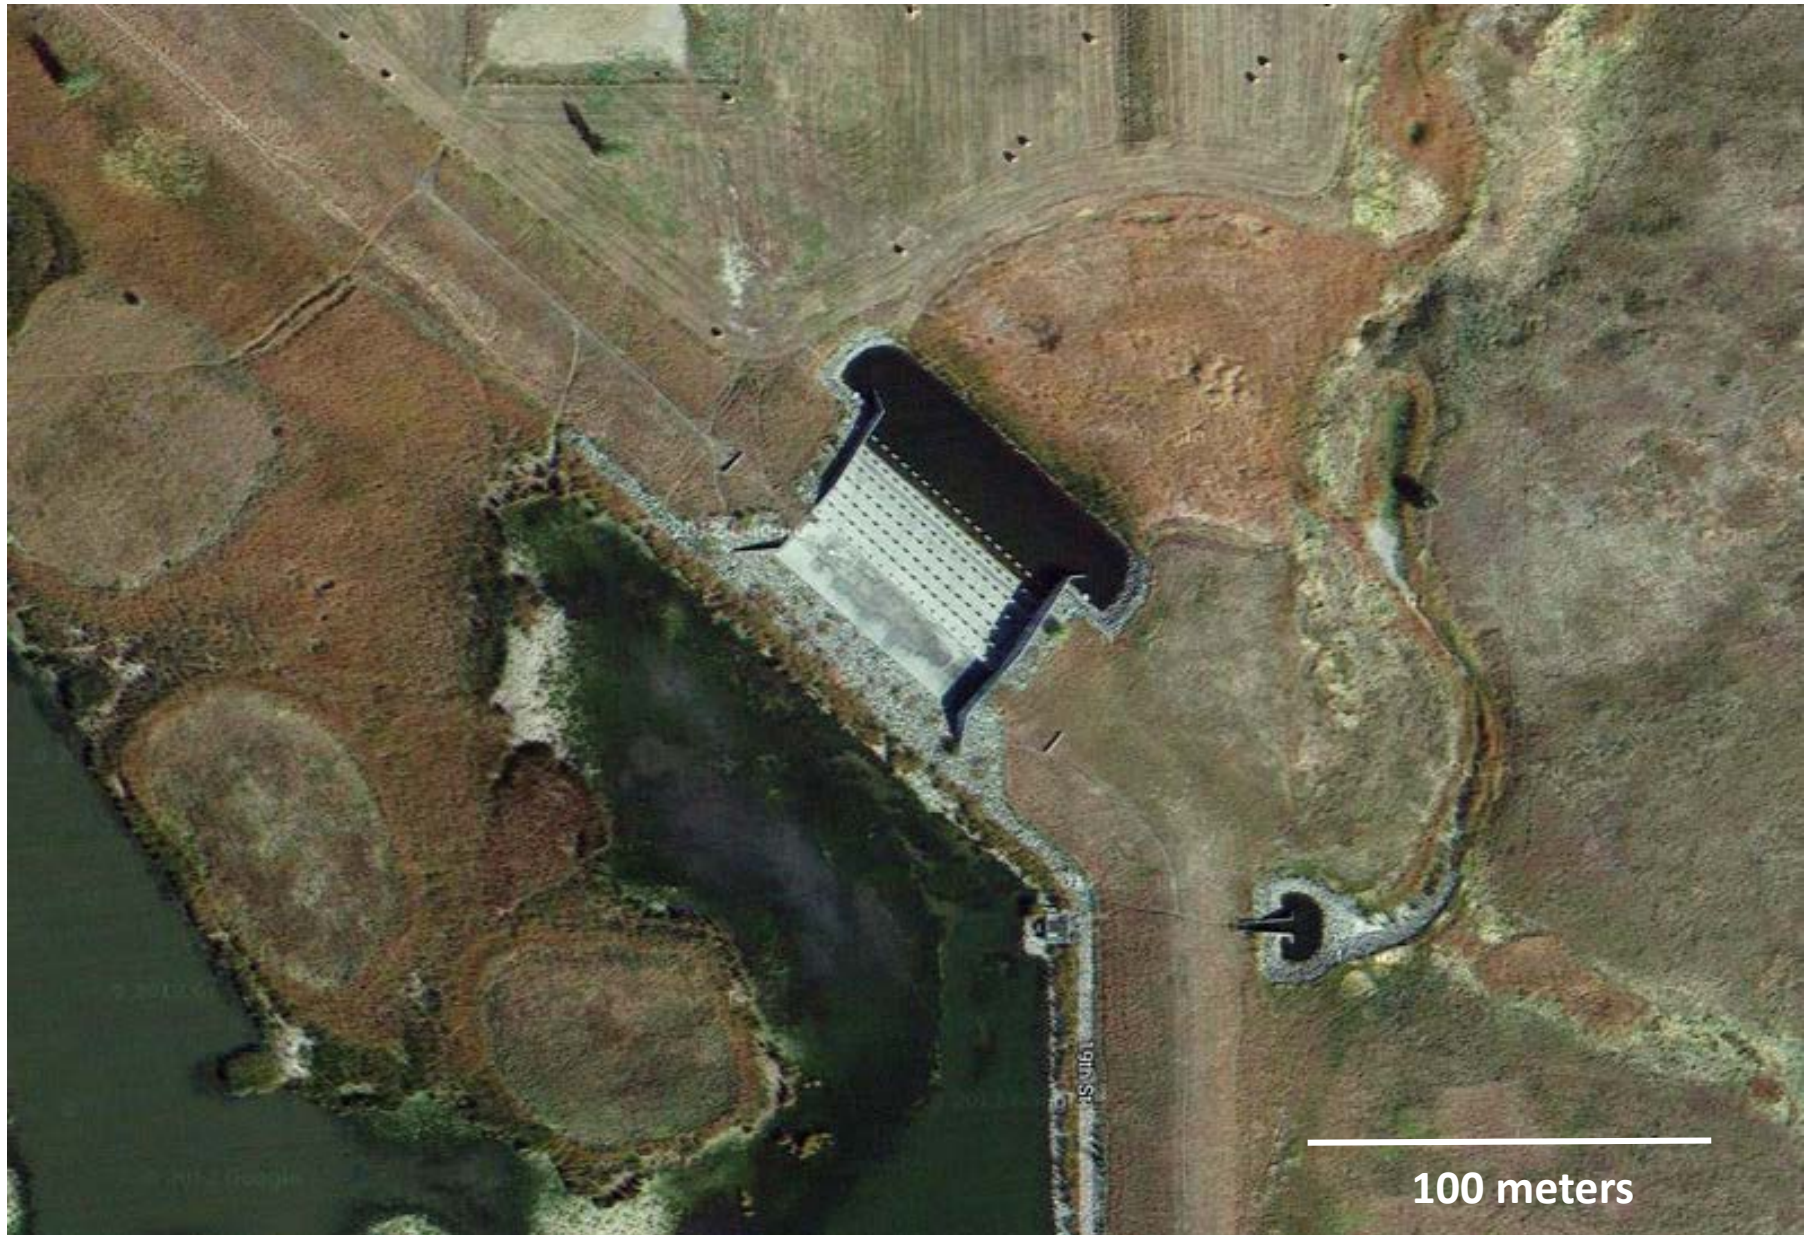
Impoundment (few miles NW of Thompson)

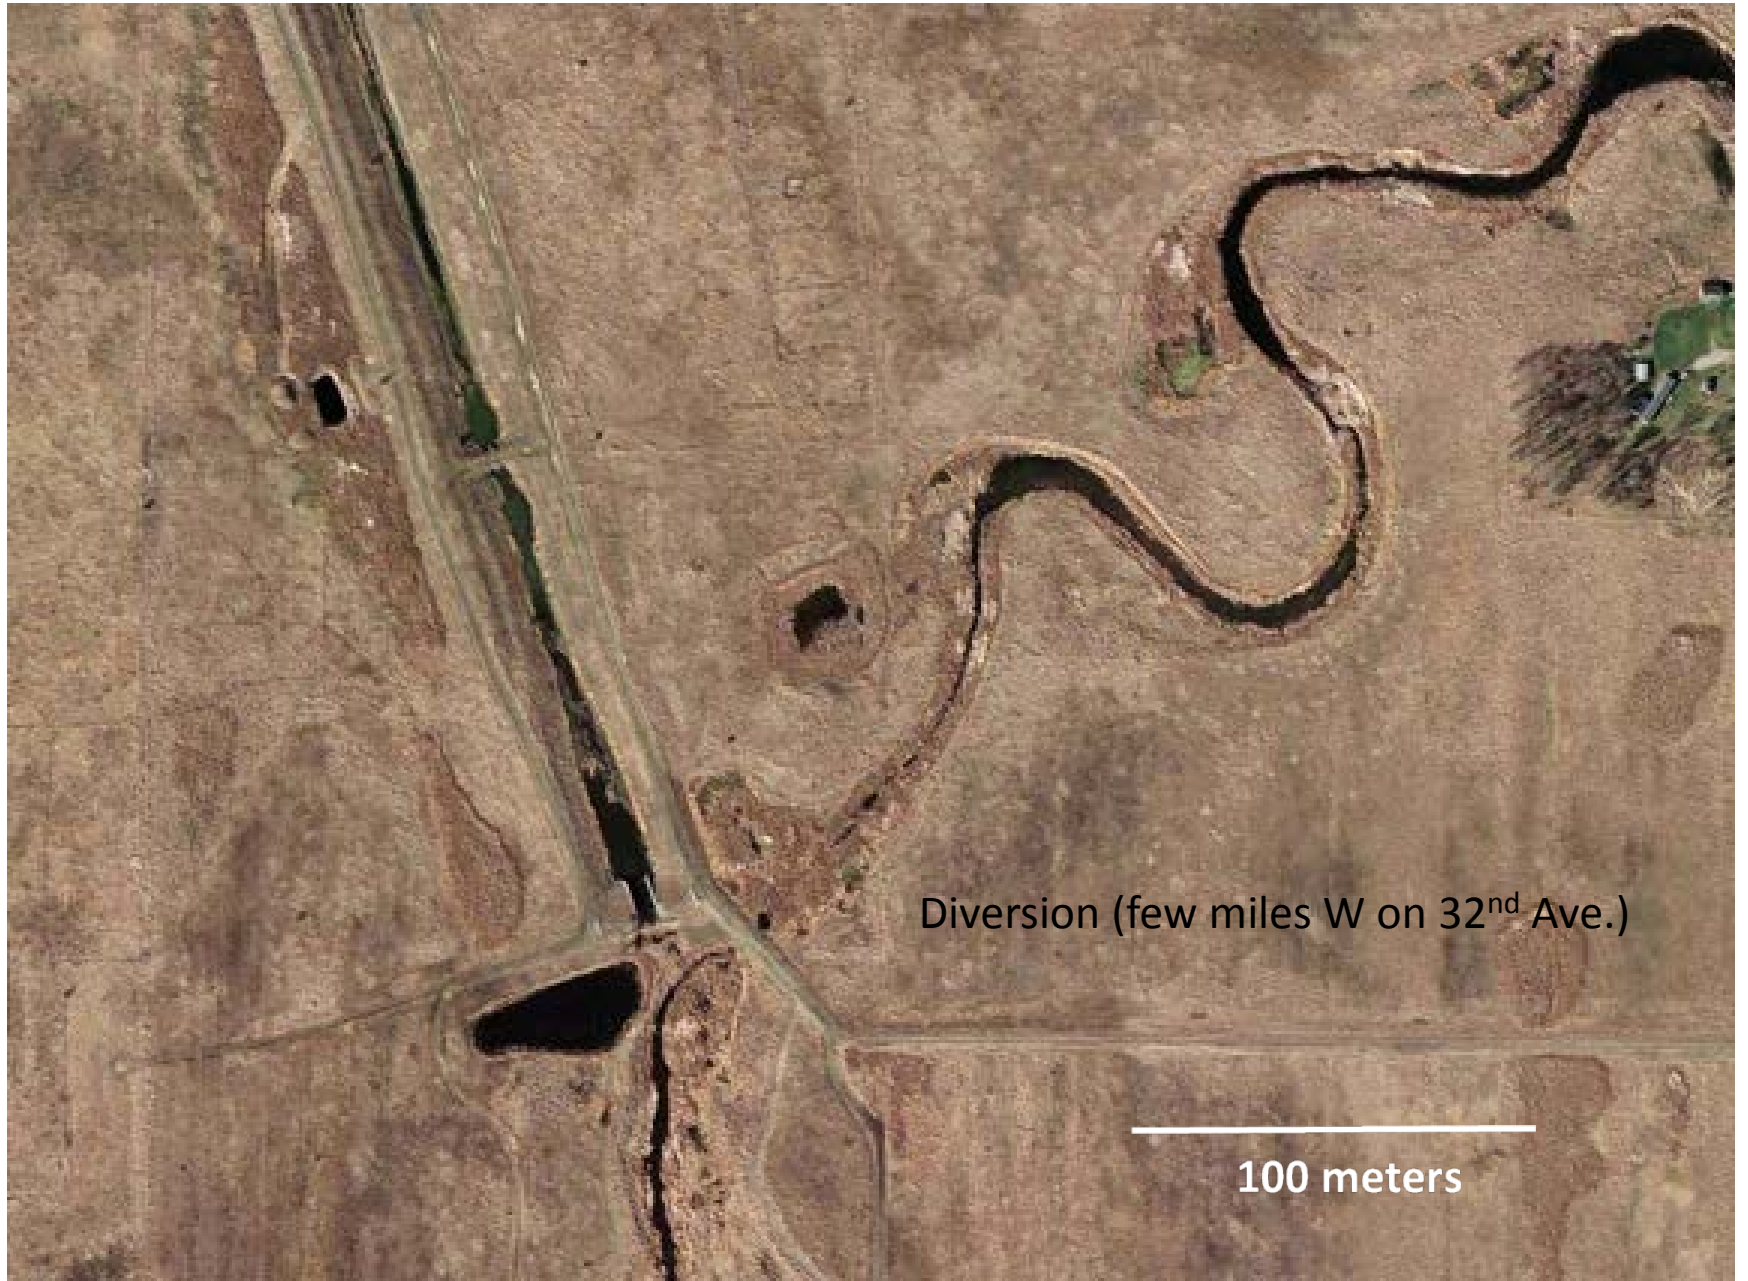
Diversion (few miles W on 32<sup>nd</sup> Ave.)

100 meters
