MEMO TO : Oil and Gas Production Companies

FROM : James L. Semerad

RE : High Efficiency Program  
**Specifically Applies to Flares (Zeeco)  
For Upstream Production Facilities**

DATE : January 13, 2022

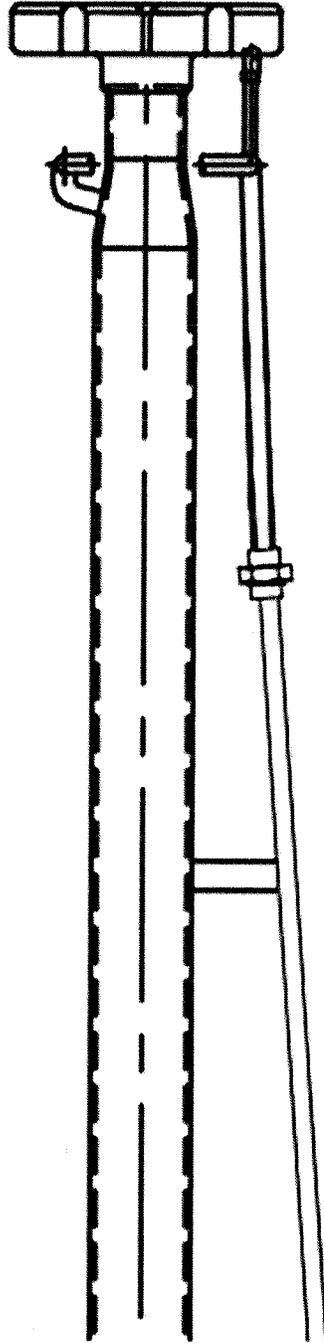
The base flare tips approved for 99.0% DRE and a CO emission factor of 0.25 lb/MMBtu with assist gas and 0.10 lb/MMBtu without assist gas are configured as shown in the images below.

*Figure 1: MJAG-3 Flare Tip*

Testing was also conducted to document CO emission factors for both the MJAG-3 flare burner tip (with assist gas) and the MJ-3 flare burner tip without assist gas. Based on the results of the testing, it appears that both flare burner tips (MJAG-3 and MJ-3) are able to achieve a CO emission factor of 0.25 lb/MMBtu and 0.10 lb/MMBtu, respectively. The evaluation reports filed by the Department are enclosed.

The Department is confident in its detailed review of the testing and is approving the Zeeco MJAG-3 and MJ-3 flare burner tips for the following reasons:

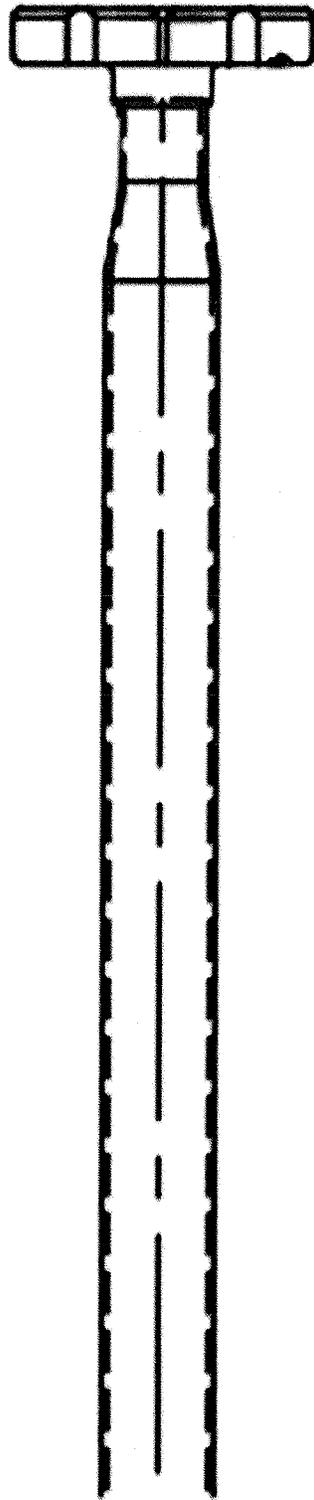
*Figure 2: MJ-3 Flare Tip*

The Series MJ Flare Tip requires little or no maintenance. There are no moving parts to replace or lubricate. The flare tip shall be inspected at every shut down or a minimum of once every 3–5 years.

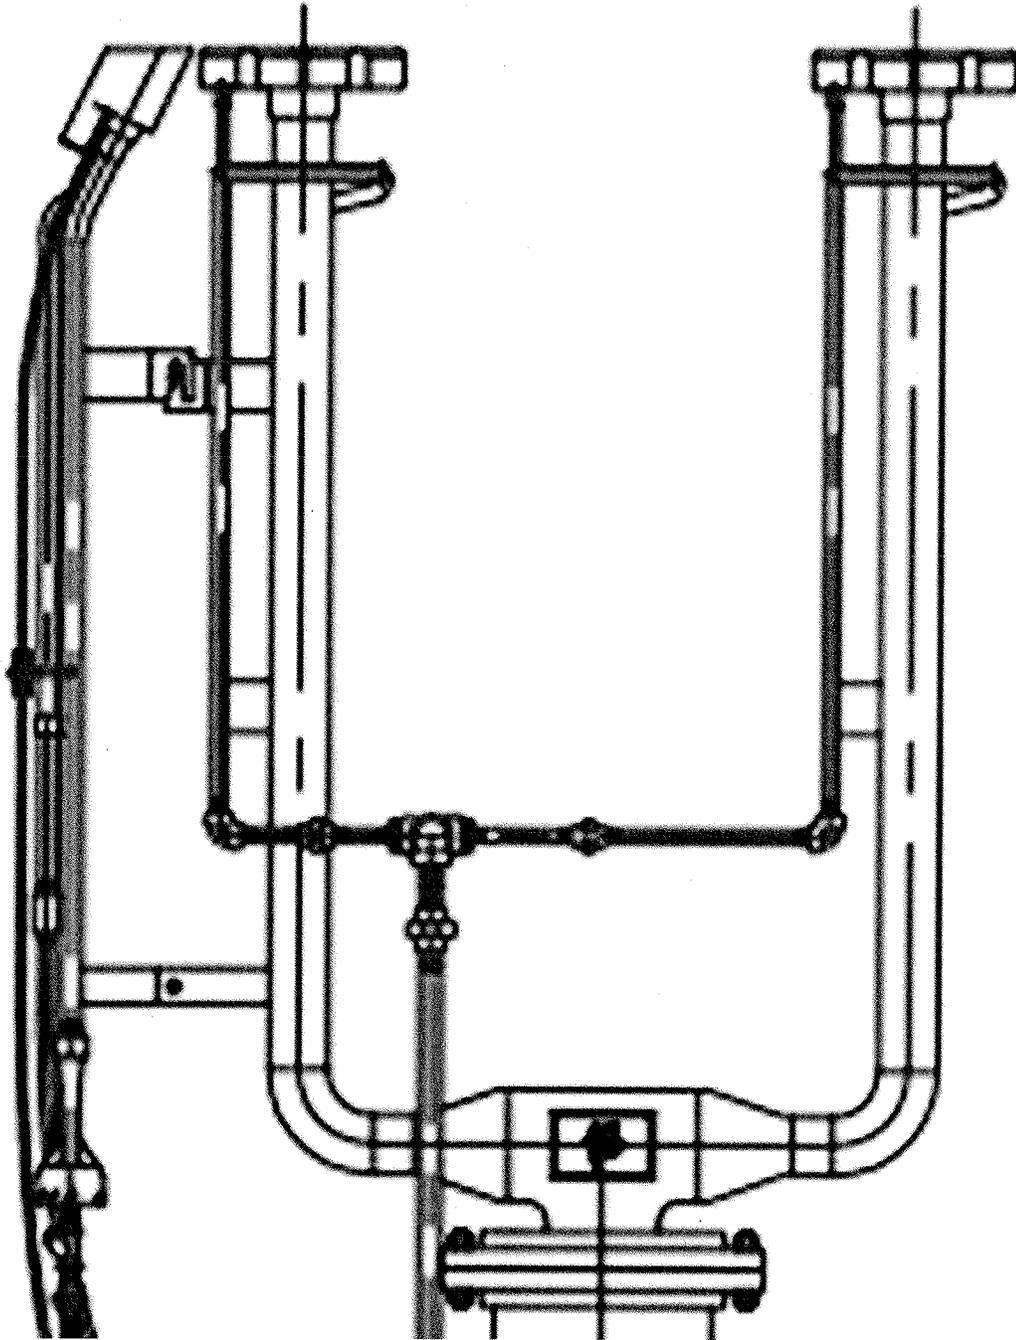
The base flare tips may be manifolded together into a common flare tip by Zeeco to meet the flow performance requirements for a given application. Some general examples of these are shown below for reference only. The number of flare tips is not limited by the figures depicted below. However, only flare tips that have been manifolded together by Zeeco will be accepted into the High Efficiency Program.

*Figure 3. 2MJAG-3 Flare Tip*

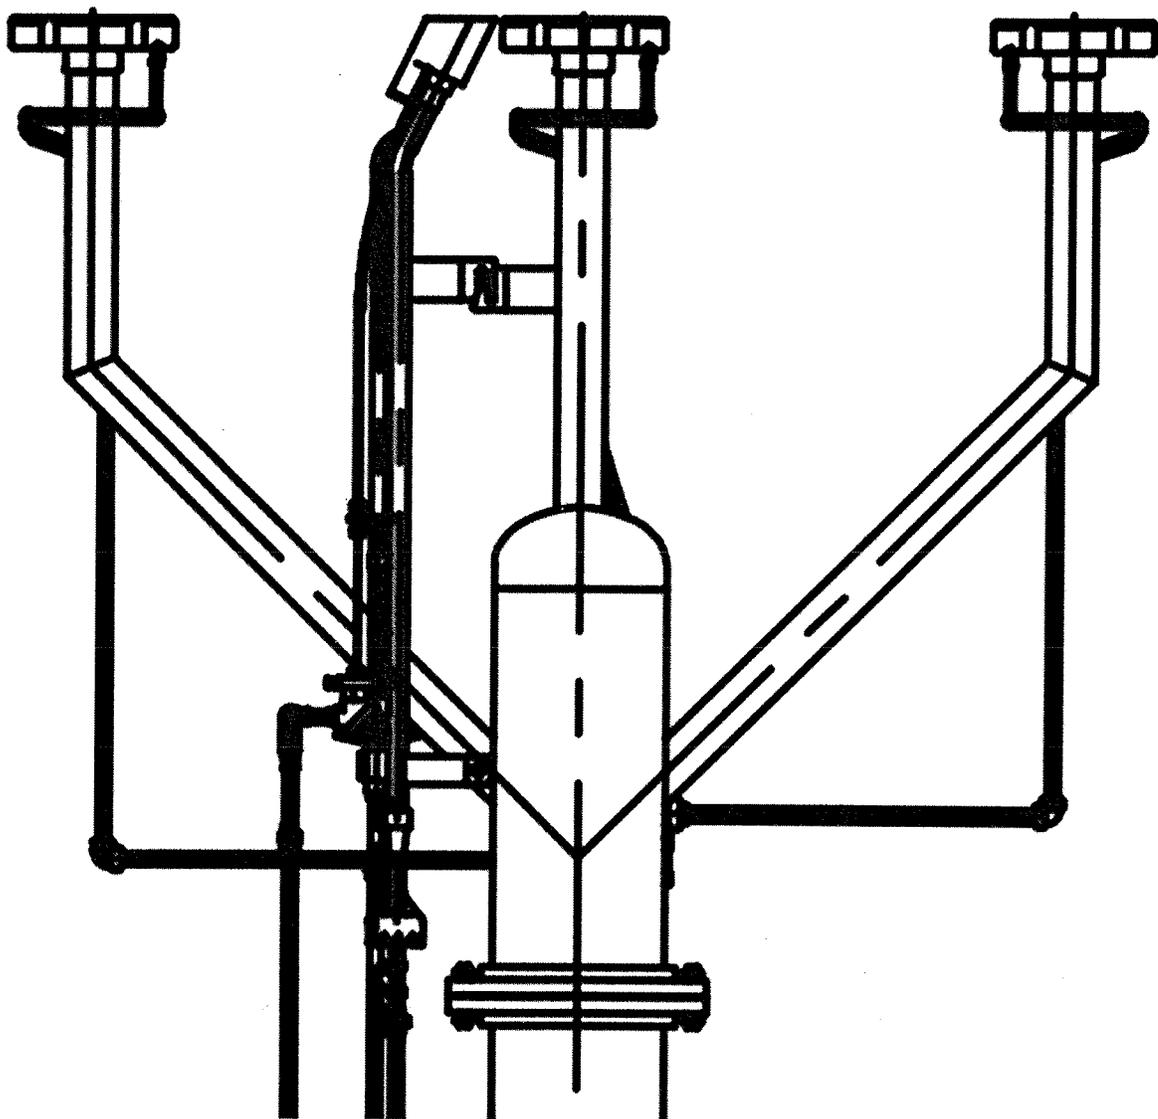
*Figure 4. 3MJAG-3 Flare Tip.*
